Topsfield Town Hall Window Restoration Project

Sheet title:
East Elevation

**Topsfield Town Hall
Window Restoration
Project**

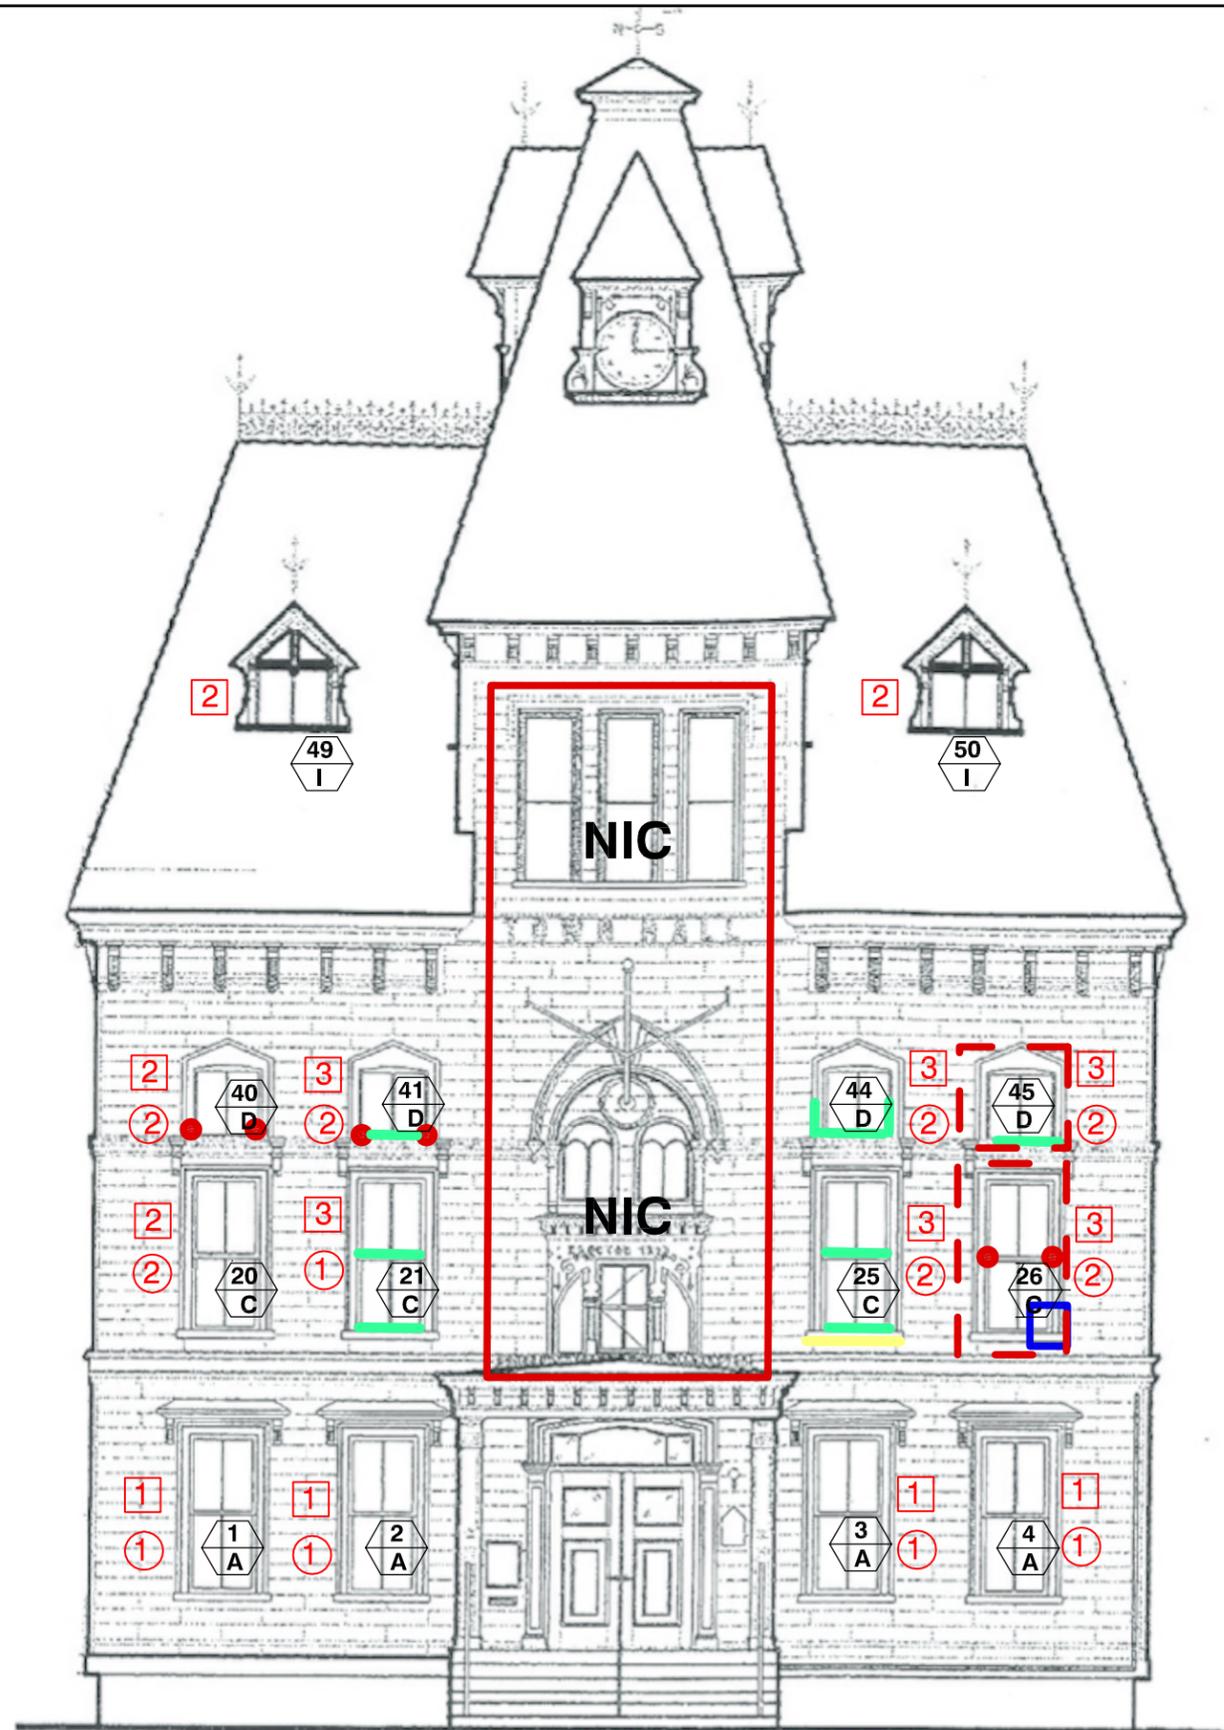
East Elevation

Possibly replace indicated sash if repair proves not feasible
-

Replace indicated sash
-

Checks in rail: Epoxy conserve
-

Checks in stile: Epoxy conserve
-

Dropped or open corner joint: Rescure rail at joint
-

Rot at corner joint: Epoxy conserve and/or Dutchman repair
-

Checks in casing or molding: Epoxy conserve
-

Badly split base molding: Replace & correct flashing
-

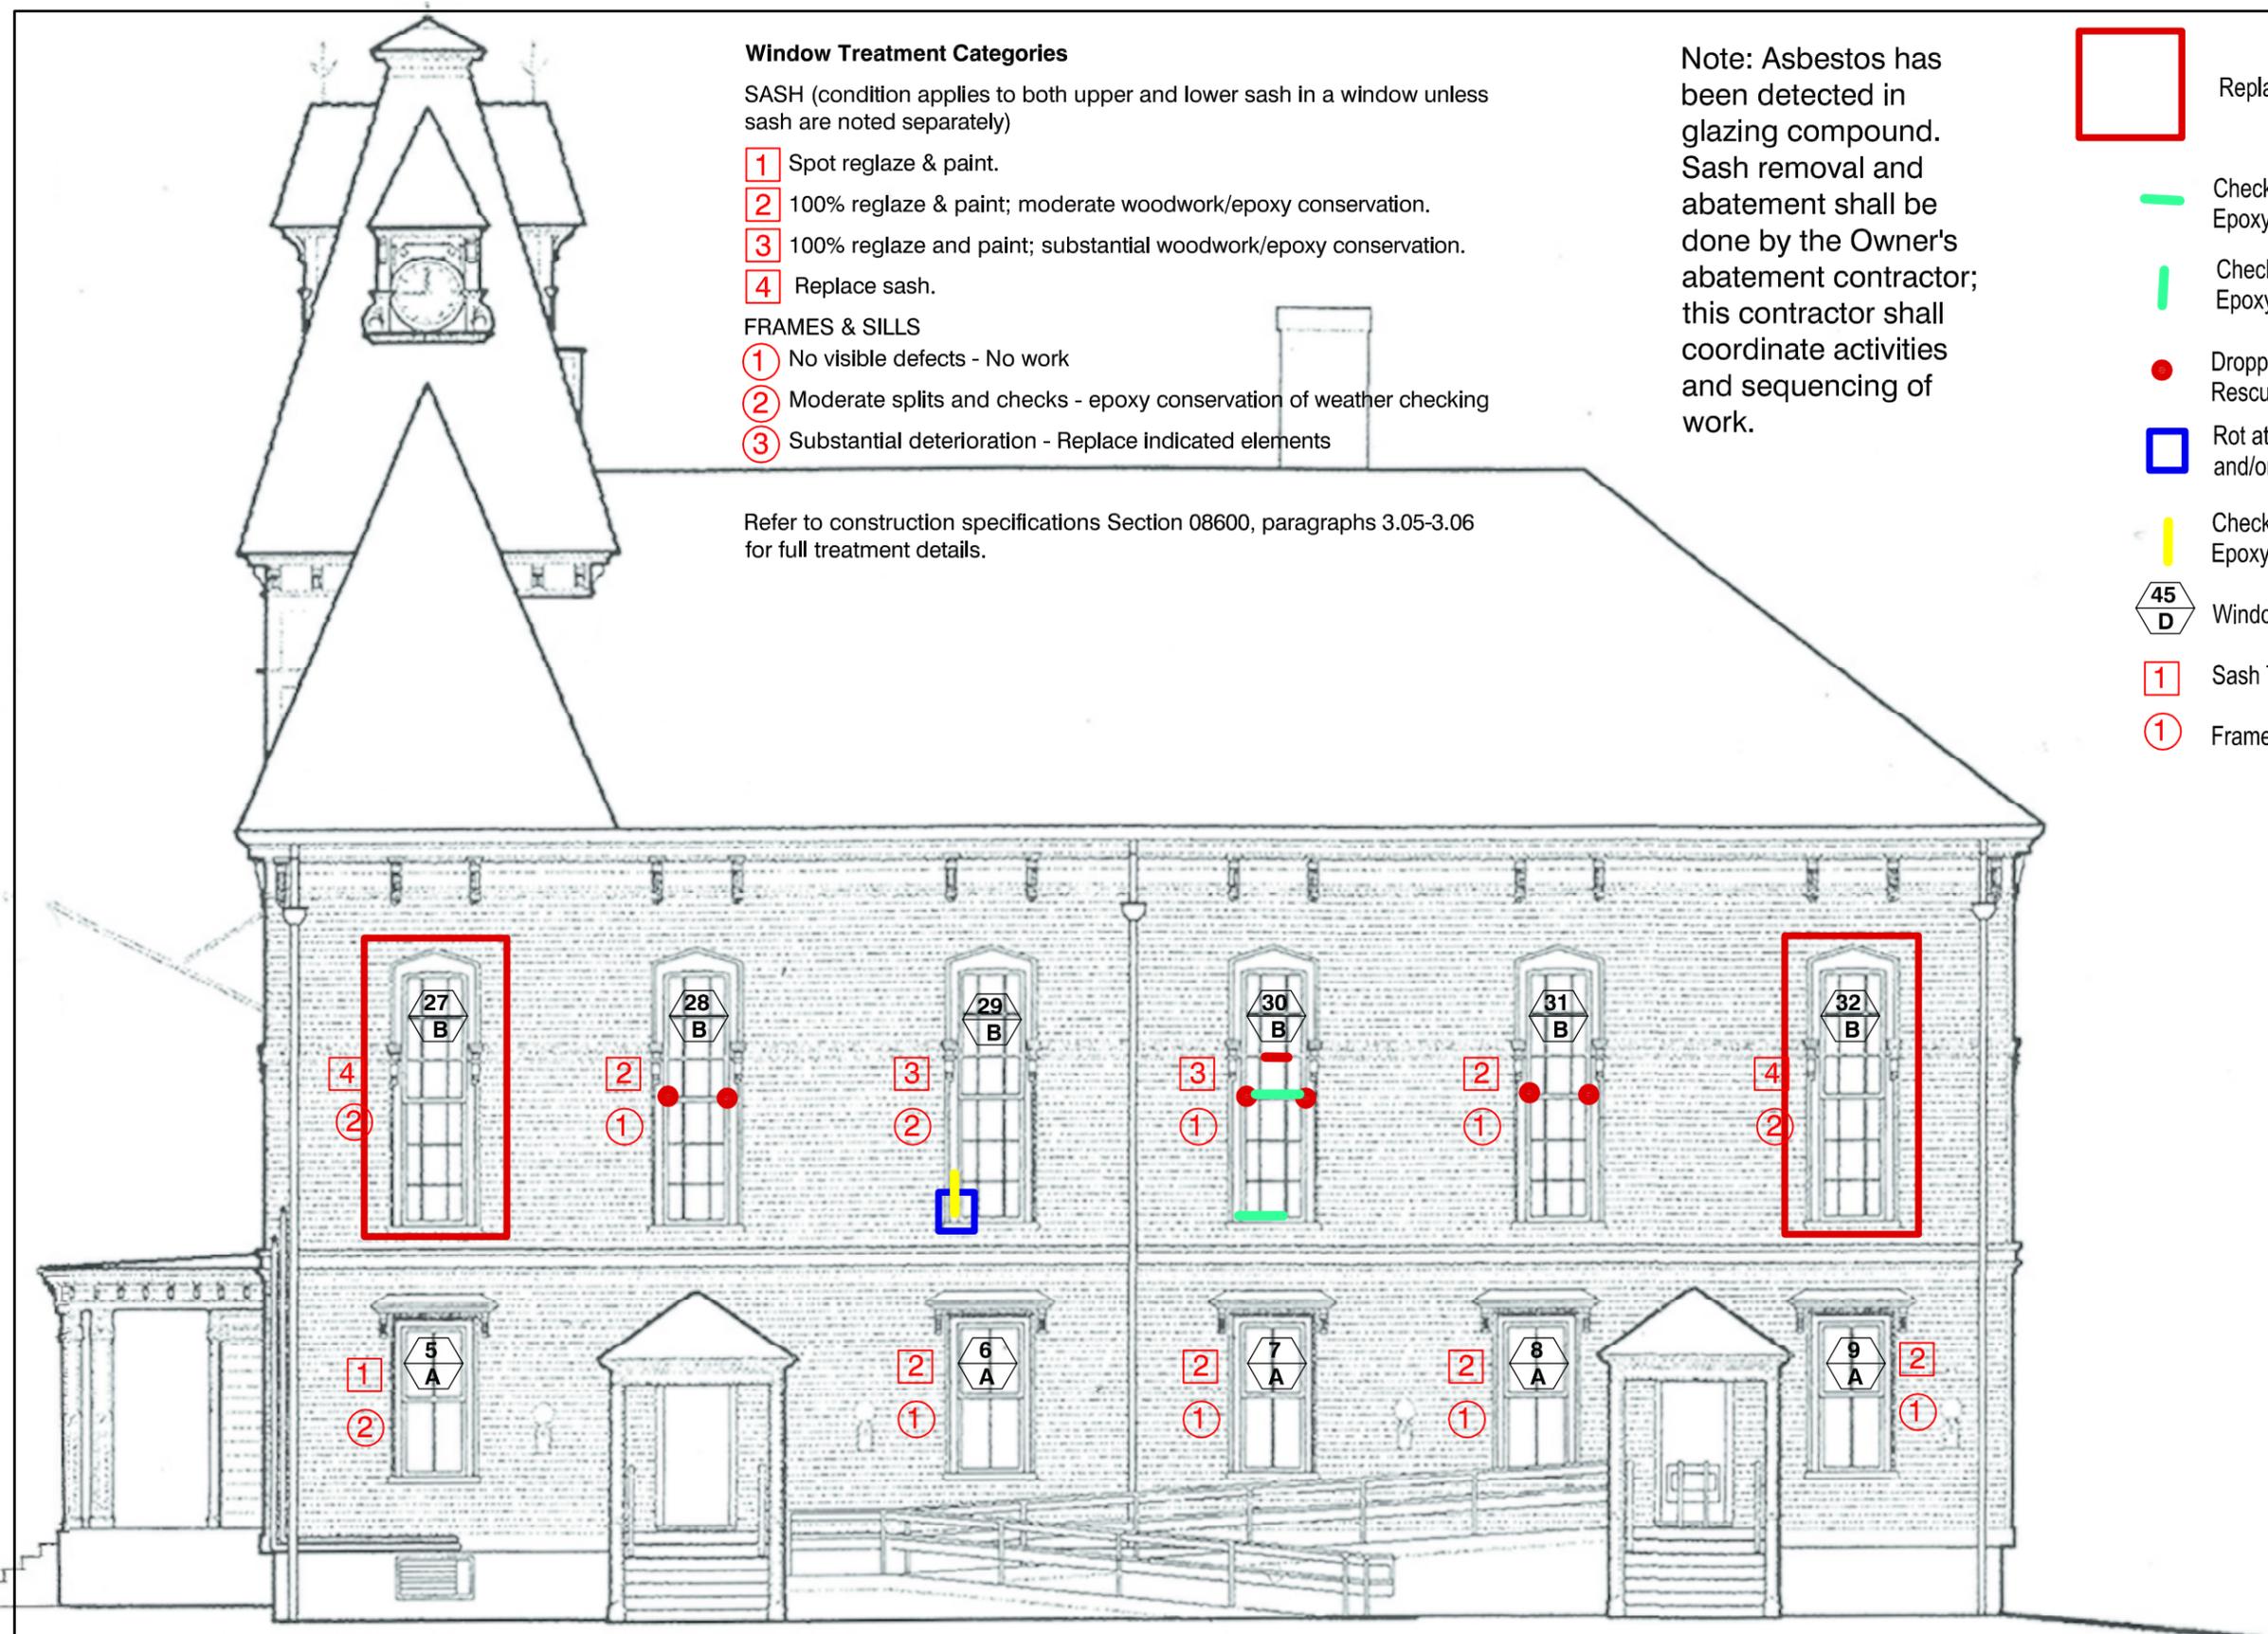
North Elevation

Replace indicated sash

Checks in rail:
Epoxy conserve

Checks in stile:
Epoxy conserve

Dropped or open corner joint:
Resecure rail at joint

Rot at corner joint: Epoxy conserve
and/or Dutchman repair

Checks in casing or molding:
Epoxy conserve

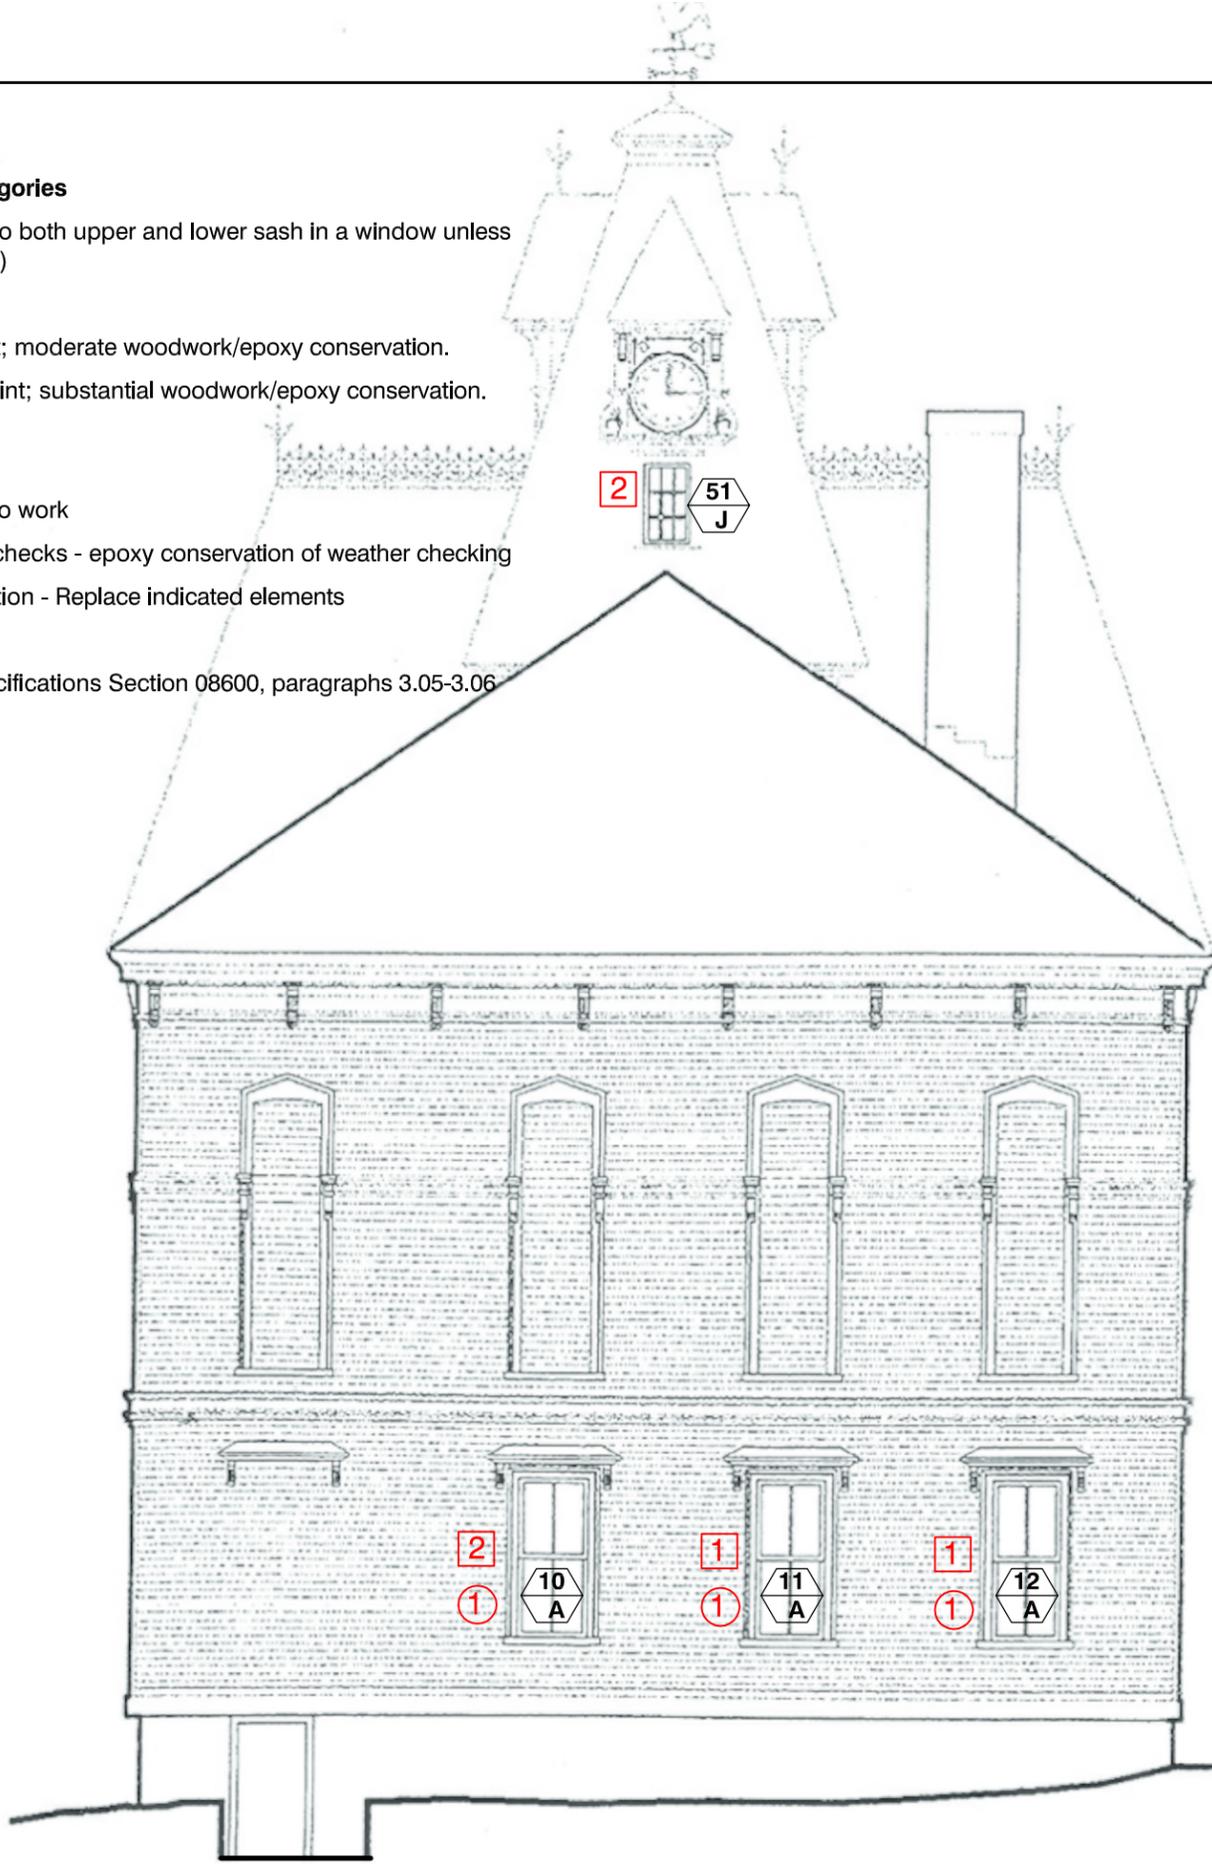
West Elevation

Possibly replace indicated sash if repair proves not feasible

Replace indicated sash

Checks in rail: Epoxy conserve

Checks in stile: Epoxy conserve

Dropped or open corner joint: Resecure rail at joint

Rot at corner joint: Epoxy conserve and/or Dutchman repair

Checks in casing or molding: Epoxy conserve
