**First Floor Plan - Photograph Locations**  
 Survey of Existing Conditions  
 Topsfield Town Hall  
 Adams & Smith / Finch&Rose  
 Scale: 1/8" = 1' - March 6, 2015

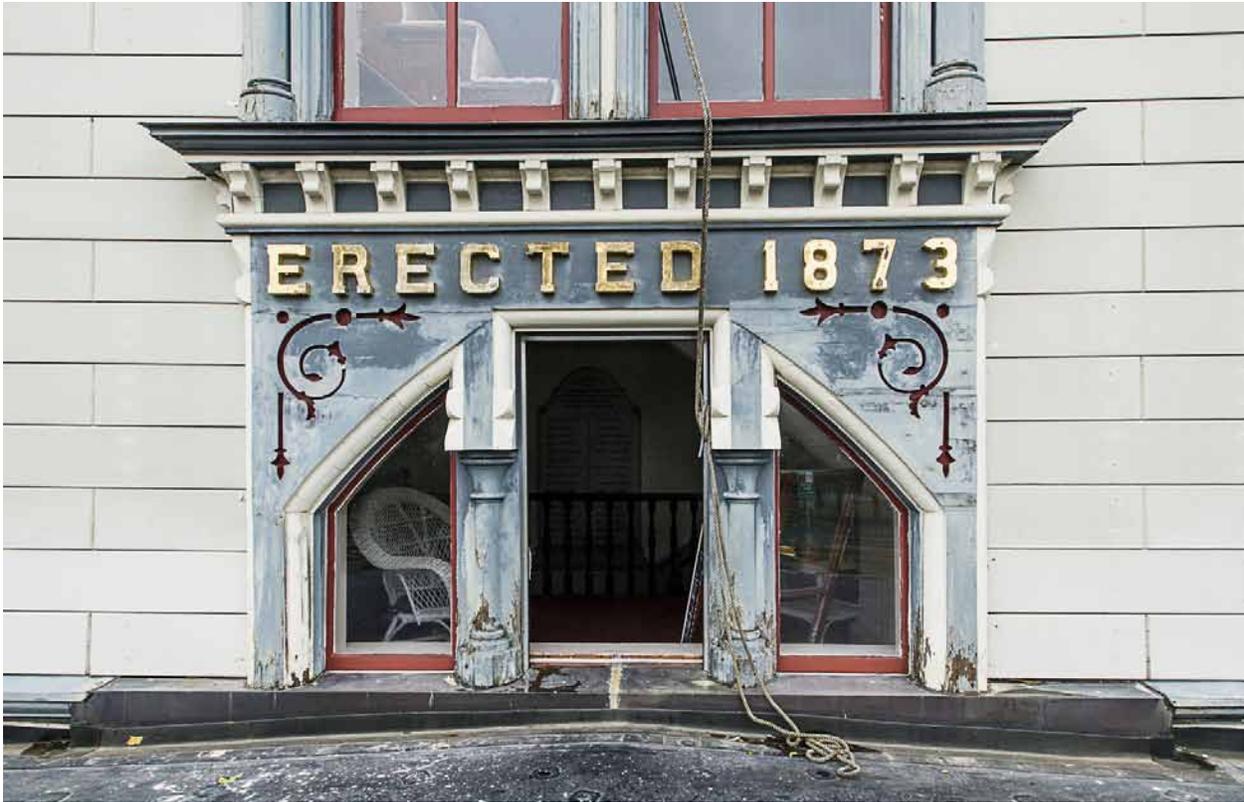
**Photo 9:** Some of the trim on the lower portions of the columns are rotting.

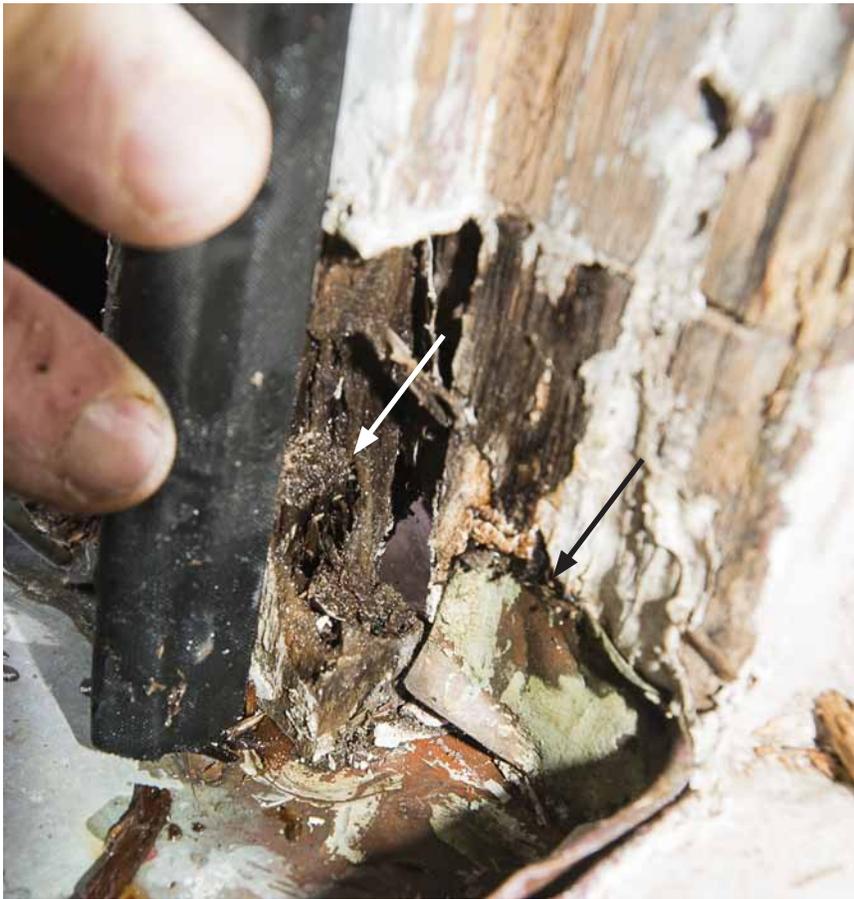
**Photo 15:** Detail of window 23 showing its badly rotted lower corner. The rot seems to be from a combination of water running down its stile and leaks from the turned base shown in Photo 13.

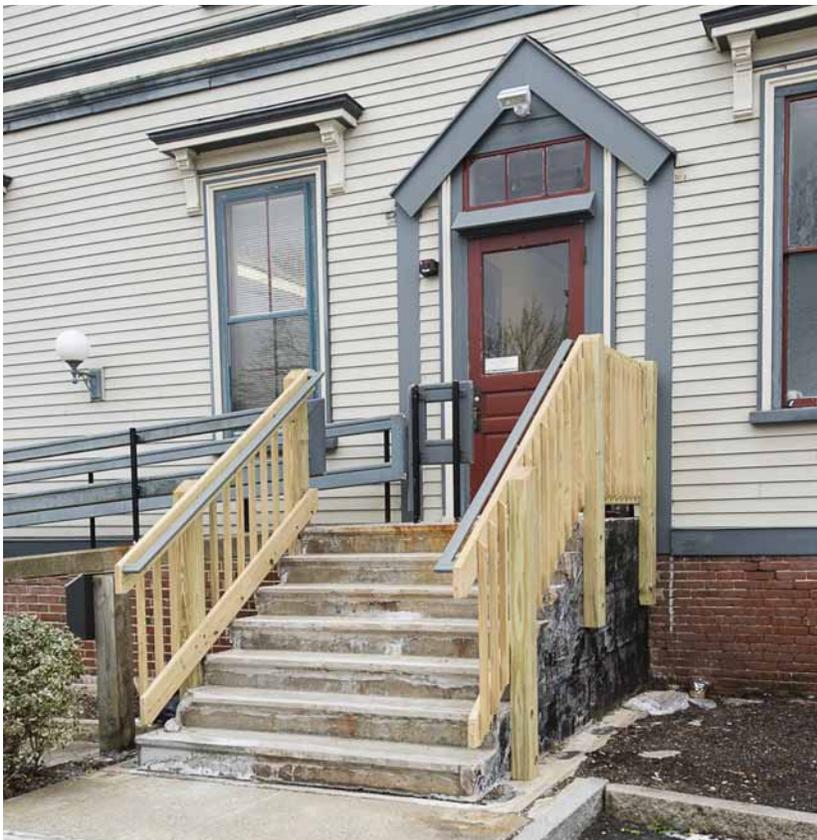
**Photo 20:** The westerly entry “doghouse” porch that was installed in 1995 (??) shows extensive rot of both trim and framing causing it to be removed last December due to concerns it might collapse under heavy snow. The easterly doghouse is only slightly better and will likely be removed this spring.

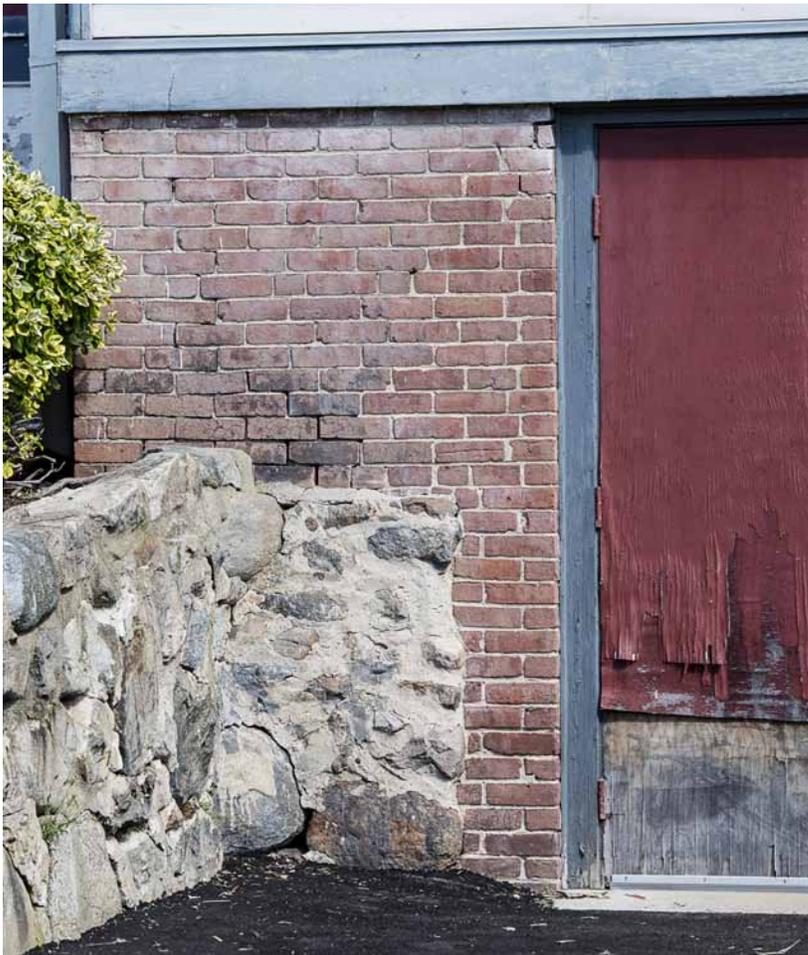
**Photo 22:** Defective mortar joints at the access ramp.

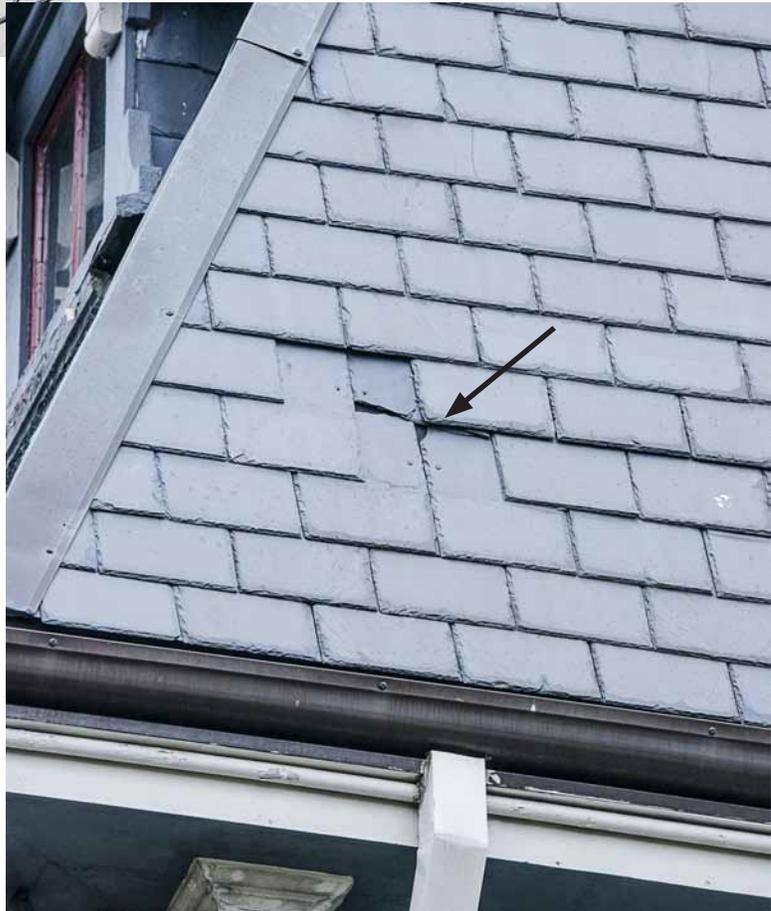
**Photo 31:** Broken slates exposing wood sheathing at the location marked with the red arrow in photo 28. Despite the breaks there do not appear to be any leaks associated with this condition.

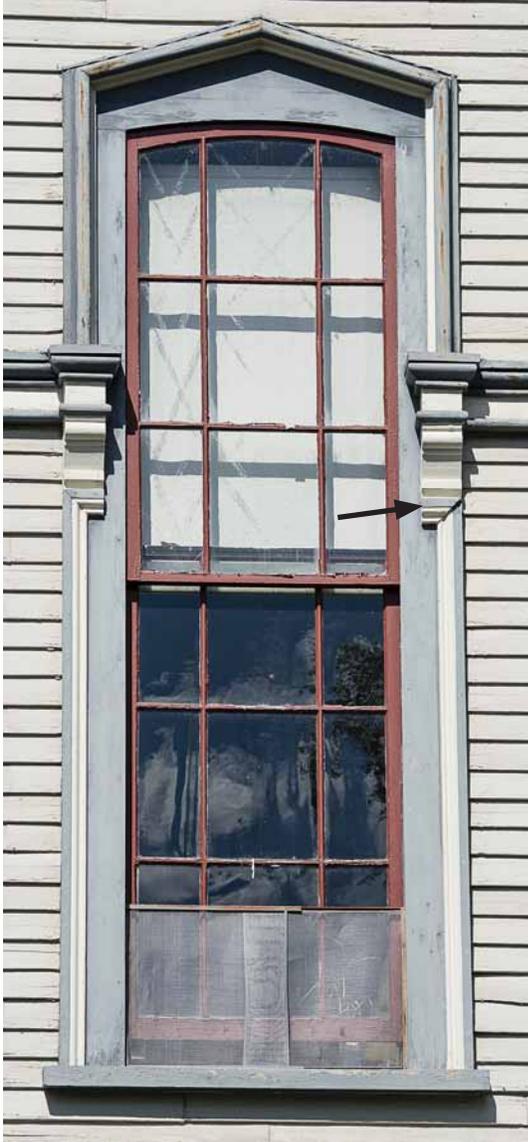
**Photo 38:** Detail showing the dropped upper sash meeting rail of window #32.

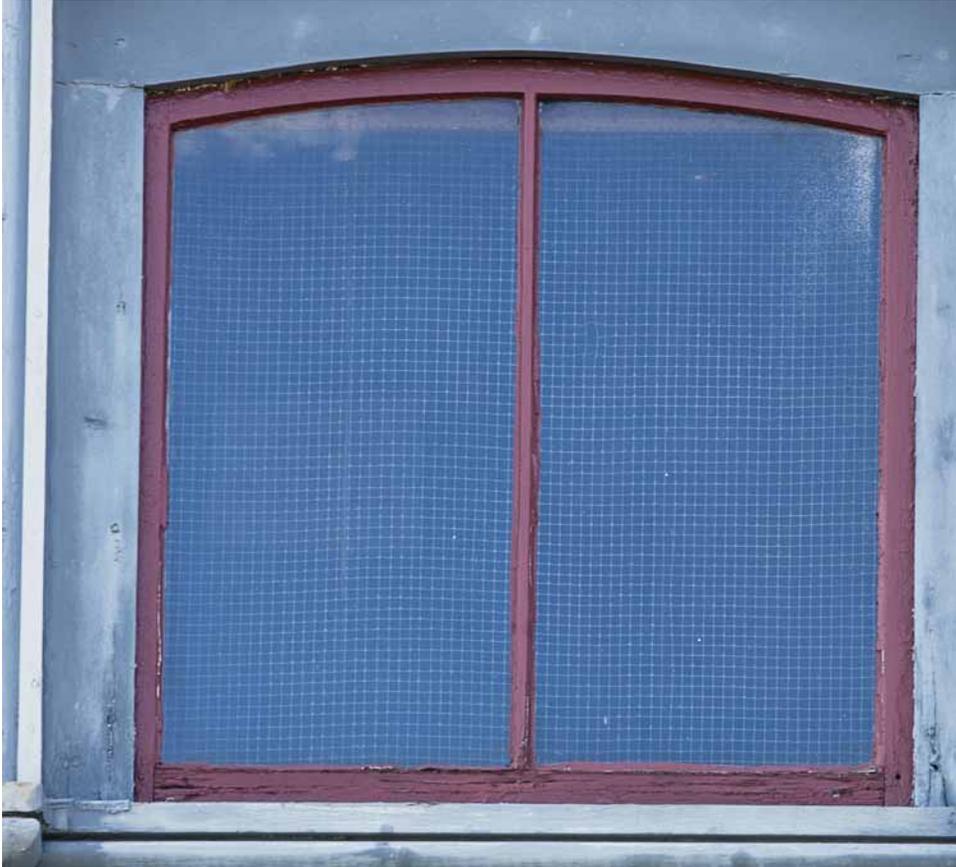
**Photo 48:** Windows#20 (type C). Other than the glazing the sash is sound. Its sill has moderate weather checking, but its wood remains sound and firm. The checks can be filled with an epoxy filler. Most sills were found to have little or no checking.

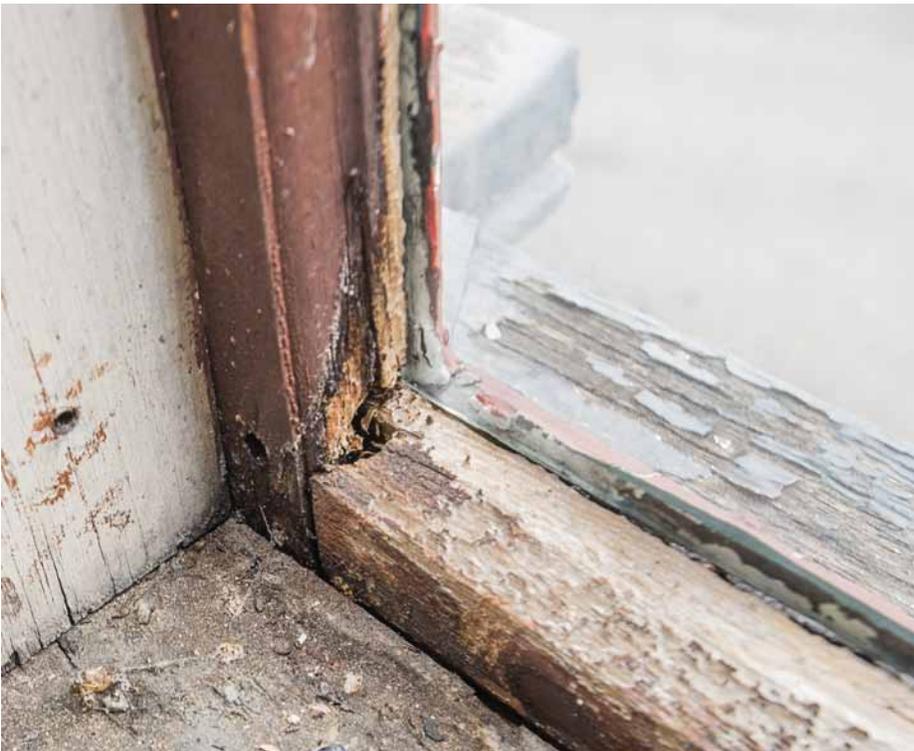
**Photo 49:** Window #44 (type D). Its bottom rail has fairly severe weather checking and 1/8" gaps at the corner joints, but the sash is other sound.

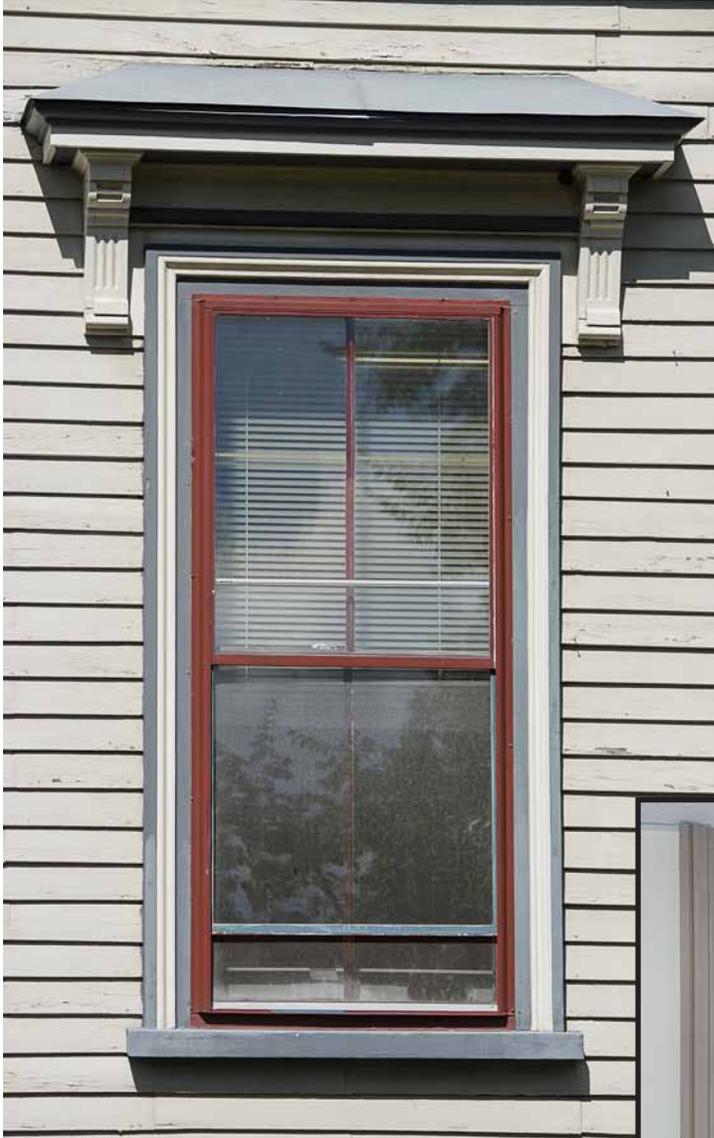
**Photo 50:** Window #40 (type D). The top interior surface of its bottom rail is severely eroded from years of condensation draining off the glass, and there is substantial separation at the corner joint. At minimum the corner joints need to be tightened; replacement of the bottom rail may be warranted due to the erosion.

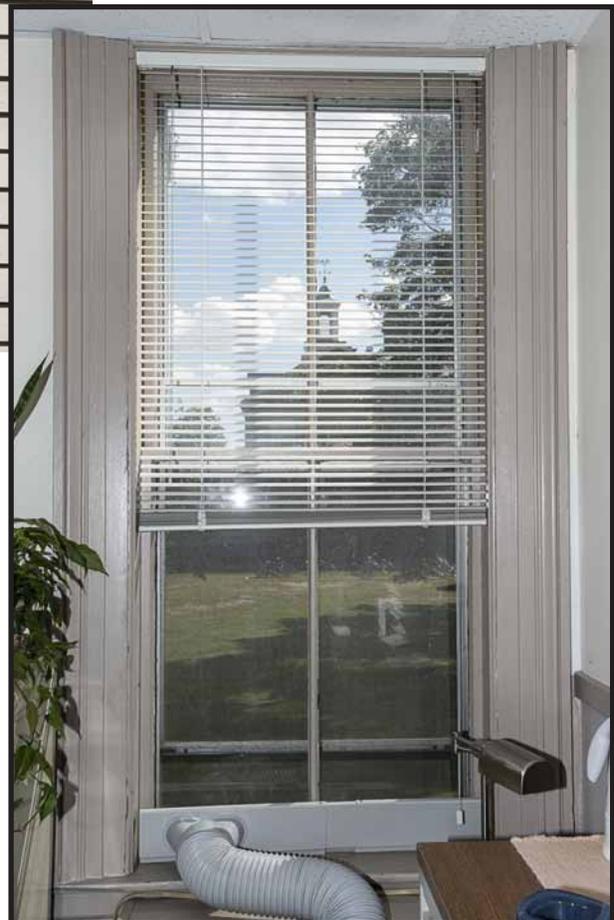
**Photo 51:** Window #16 (type A) on the south facade. All the first floor windows are of this type, and all are fitted with aluminum storm windows. The storms have protected the sash from the extensive glazing deterioration and weather checking that is present on most of the upper floor sash. The sills are also in sound condition. The projecting window heads are covered with sheet metal. As the storm windows are at least 20 years old, they are not as tight as new storms would be, and they tend to be cranky to operate.

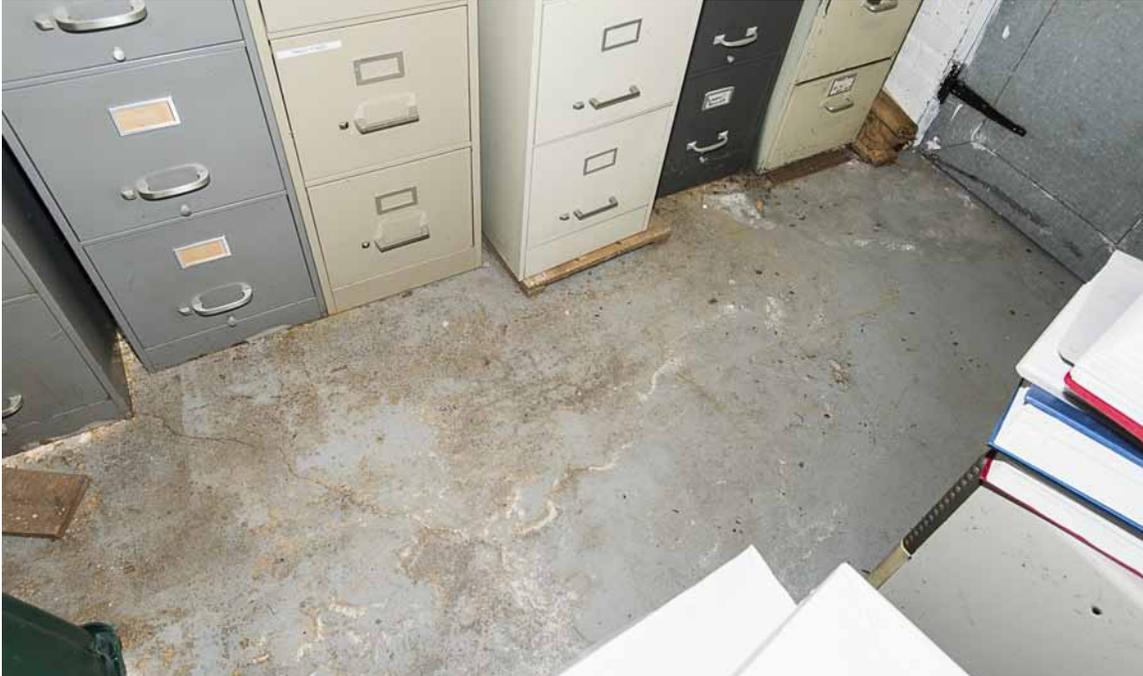
**Photo 101:** Southwest corner of basement showing typical document storage use. The brick portion of the foundation wall is above grade. The south wall is on the left. Some water stains are visible on the floor from past dampness.

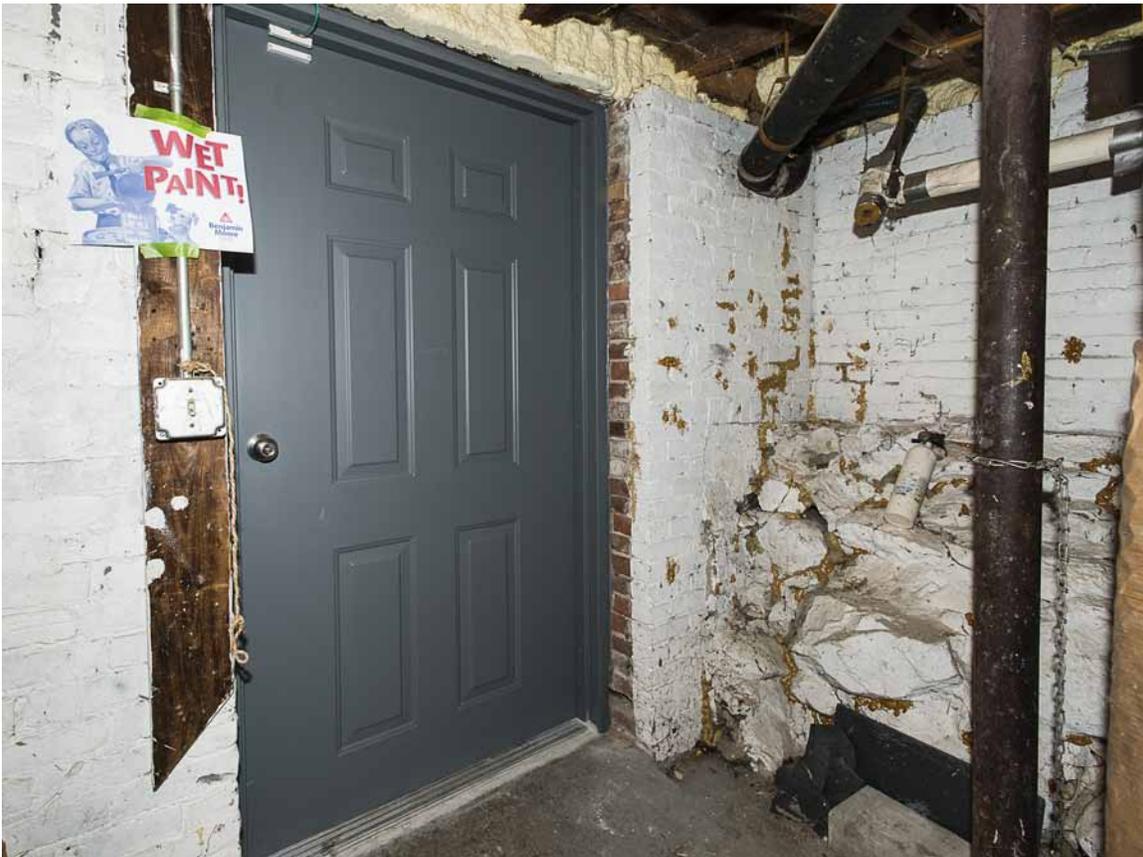
**Photo 102:** Room below the Town Clerk's office showing stains from past dampness or leaks. No signs of current leaks were observed.
