TOWN BUILDING ASSESSMENT STUDY AND CAPITAL MASTER PLAN  
Town of Topsfield, Massachusetts

**Park & Cemetery**

Pine Grove Cemetery, Haverhill Road.

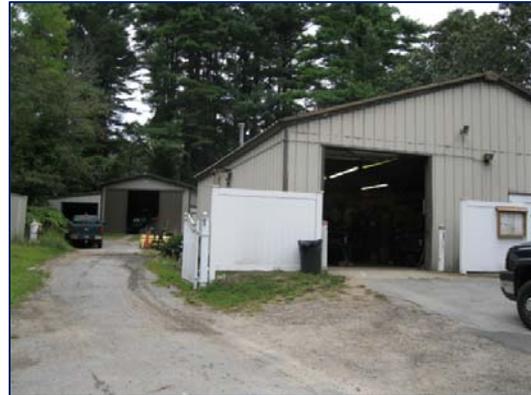
Building 1 is the main building and includes the office areas, restrooms and garage space. This is the building that families need to visit to purchase cemetery lots and is not appropriate for this function.

- 2 Office walls have exposed studs on garage side. All wood framing should be finished with gypsum wallboard. (13)
- 3 Toilet rooms are not of the correct dimensions for handicapped accessibility and finishes are not appropriate for client use. Grab bars are missing in women's room Toilet rooms should be reconstructed to the correct dimensions and have new durable finishes such as porcelain tile floors, ceramic tile walls and new ceilings. (30)

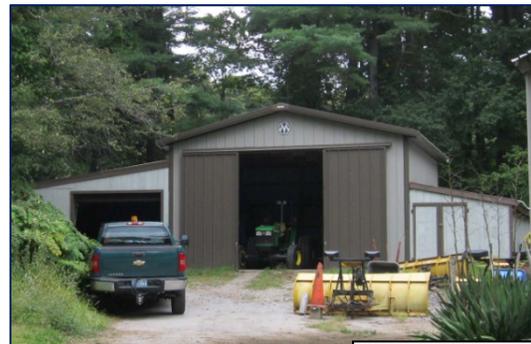
Building 2 has two wood framed wings, without floors, that are constructed on concrete piers. These spaces are damp and not appropriate for the storage of equipment.

- 4 Wood framed wings are built on pier foundations and are without a floor slab. Wood doors are warping. Any equipment stored in these wings is exposed to rodent damage and moisture damage. The two wood framed wings should be removed but if retained should be provided with a concrete slab and doors replaced on the smaller building. (47)

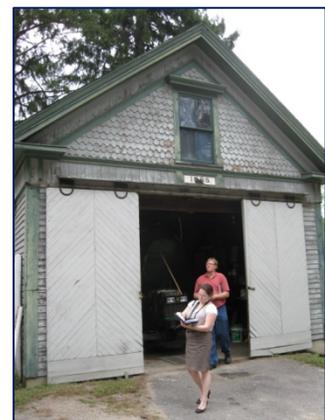
Building 3 is used as a garage, but architecturally it is the most significant structure on the site.

- 2 Windows should be restored and interior storm panels added (including attic windows). (116)
- 2 Exterior should be scraped and painted. Any severely water damaged shingles or siding should be replaced. (79)
