First Floor Plan - Photograph Locations
 Survey of Existing Conditions
 Topsfield Town Hall
 Adams & Smith / Finch&Rose
 Scale: 1/8" = 1' - March 6, 2015

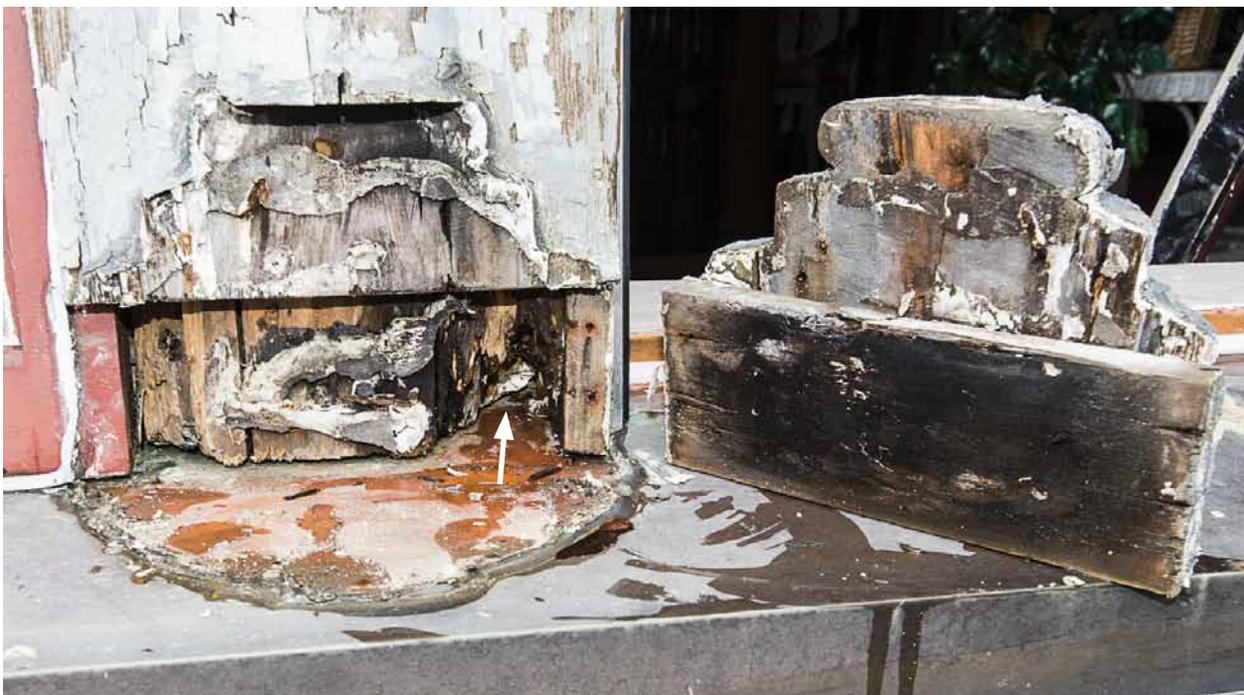
Photo 12: Turned base to the pilaster between windows 23 & 24 has splits and weather checks that allow water penetration under and behind it. Caulking at its bottom traps any water that gets behind it.

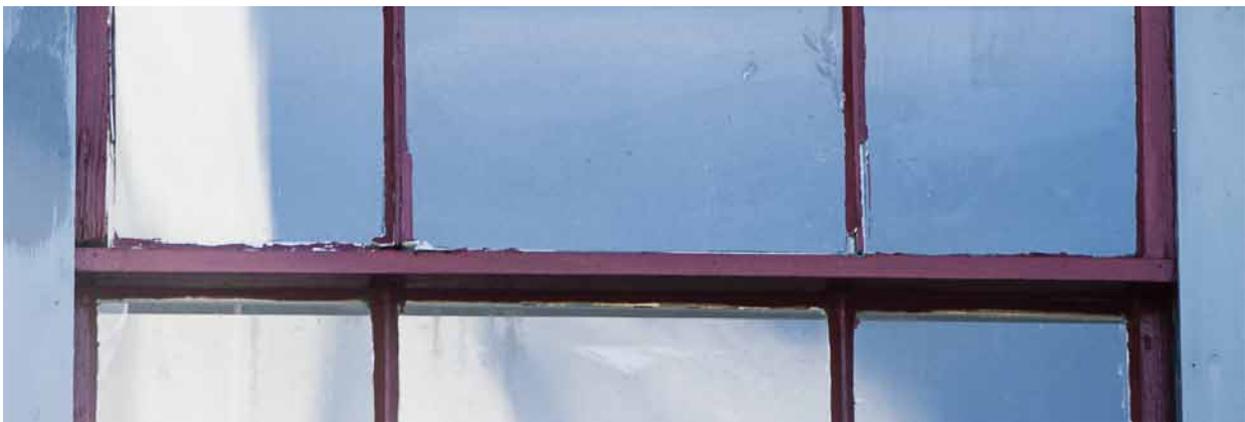
Photo 35: Detail of the knife blade profile muntins used on the replacement sash at windows #27 and 38. These windows have never been painted on their interior side.

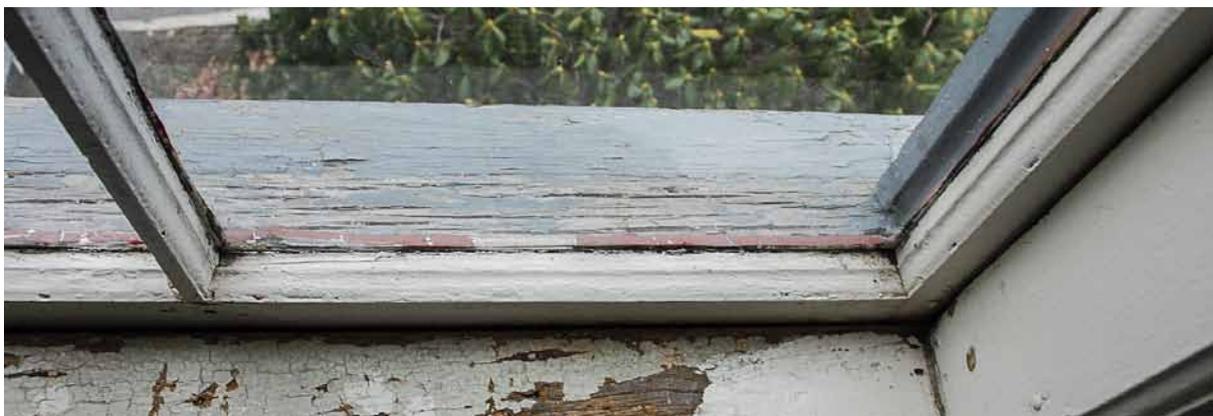
Photo 47: Windows #25 (type C) on the front facade. The bottom rail of this window has extensive checking in the bottom rail needing substantial epoxy conservation.
