**First Floor Plan - Photograph Locations**  
 Survey of Existing Conditions  
 Topsfield Town Hall  
 Adams & Smith / Finch&Rose  
 Scale: 1/8" = 1' - March 6, 2015

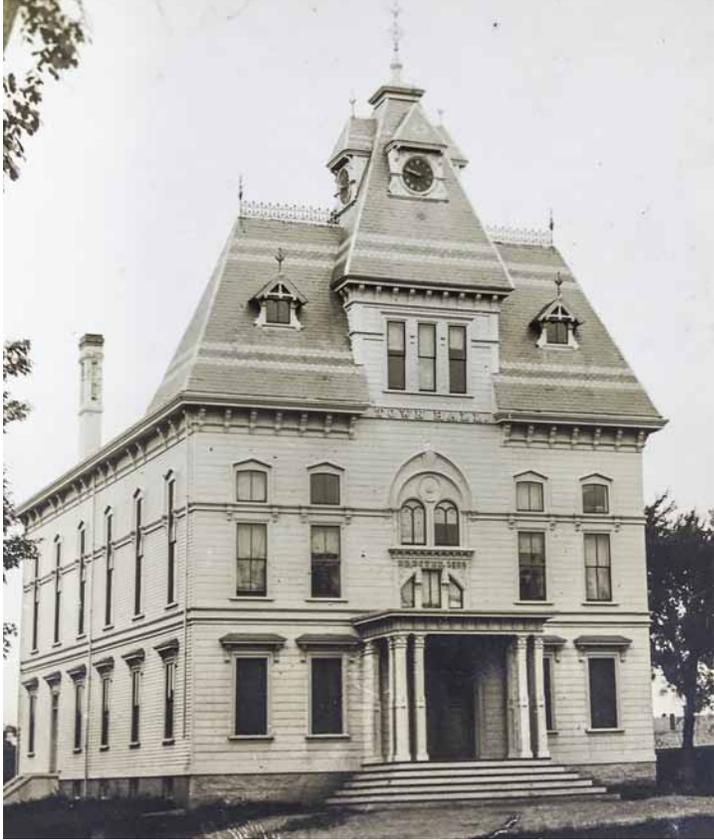
**Historic Photo 1:** Undated historic photograph showing the original roof with patterned and multicolored slate bands. The entry porch has additional columns (a cluster of three rather than the current two columns at the front corners), as well as a three sided stair.

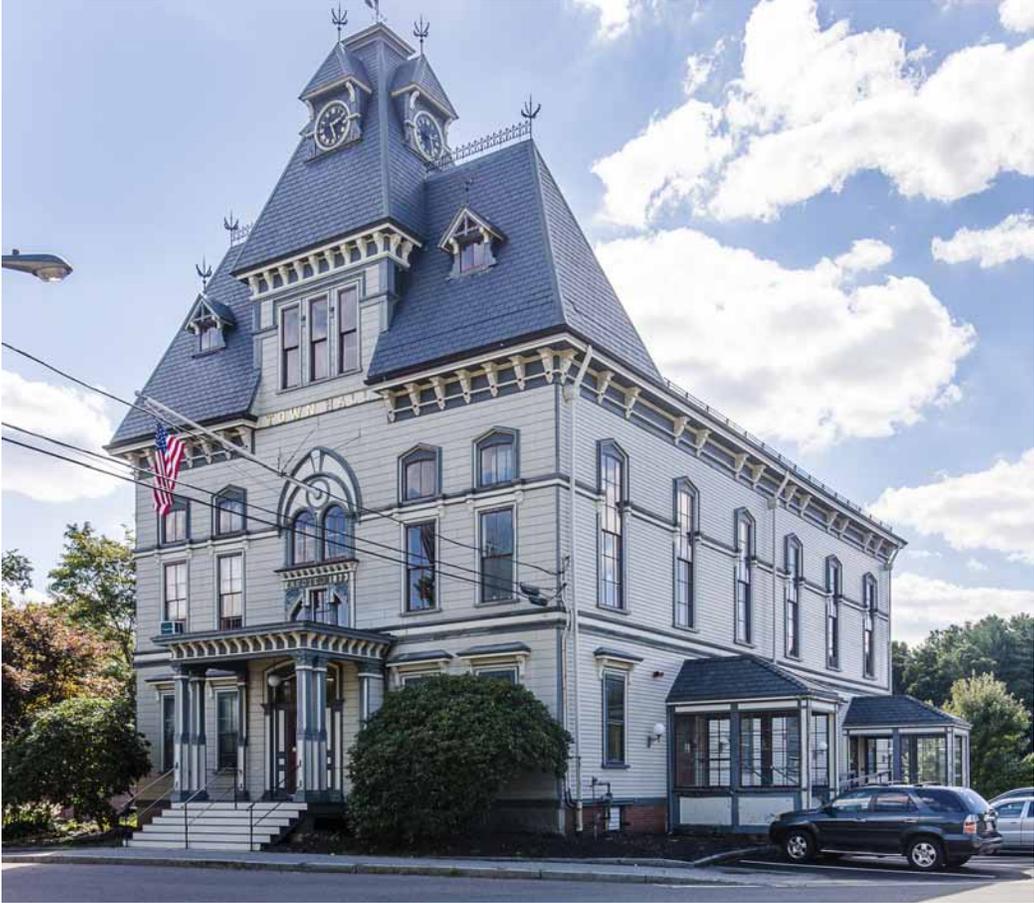
**Photo 1:** Front (east) and north side facades.

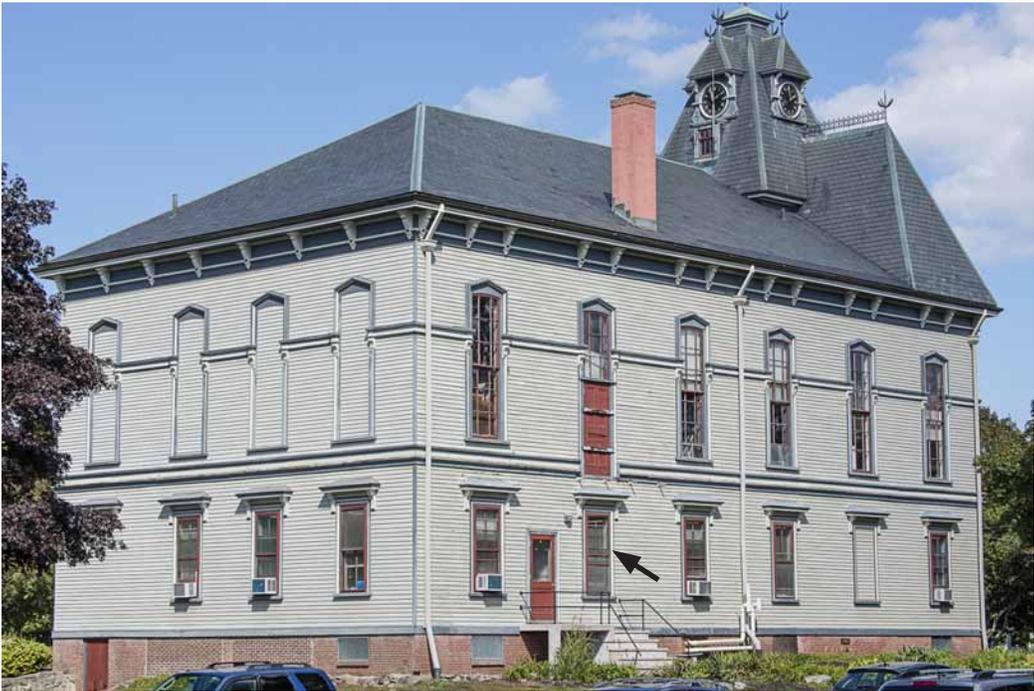
**Photo 2:** Rear (east) and south side facades. The chimney was recently rebuilt with cement block. The arrow points to a window that replaced an original door that is visible in historic photo 1.

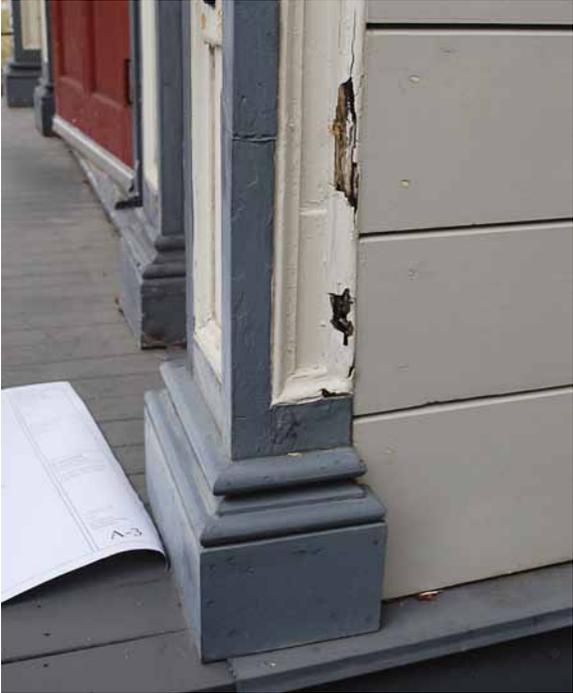
**Photo 8:** Many of the trim elements are rotting.

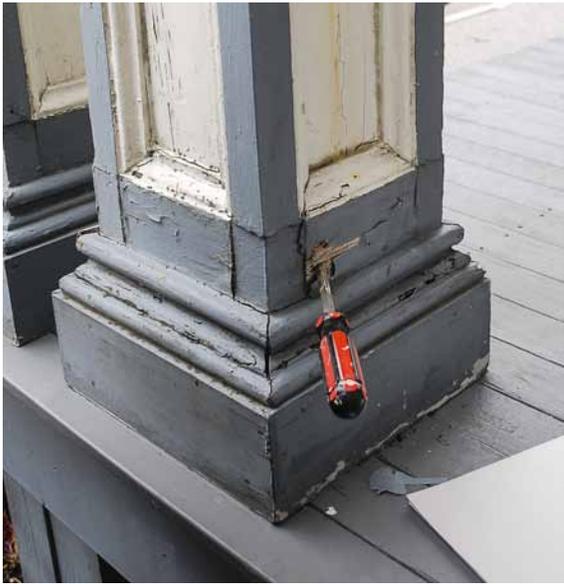
**Photo 9:** Some of the trim on the lower portions of the columns are rotting.

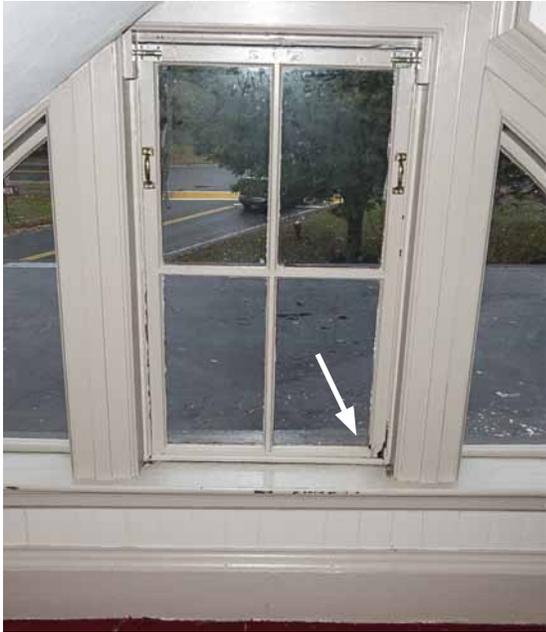
**Photo 14:** Interior side of window 23, which is removable from the interior to access the entry porch roof. The arrow points to its severely rotted lower corner.

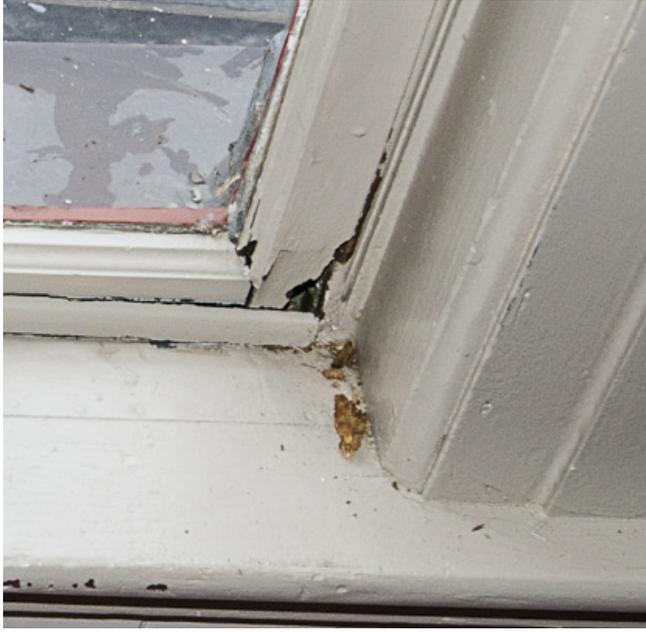
**Photo 15:** Detail of window 23 showing its badly rotted lower corner. The rot seems to be from a combination of water running down its stile and leaks from the turned base shown in Photo 13.

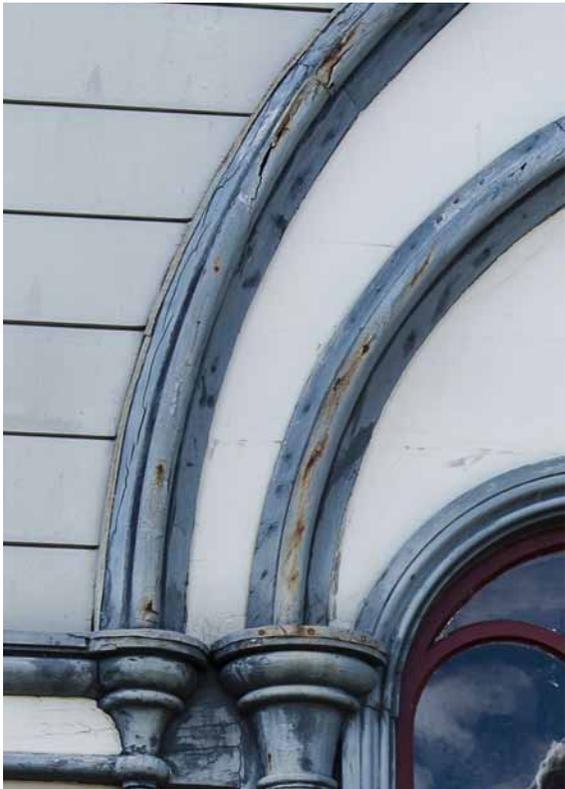
**Photo 18:** Arched trim above window 42 has substantial cracks, probably started by rusting nails. The outer trim is substantially worse than the inner one. The turnings below the trim appear to be sound and are capped with copper.

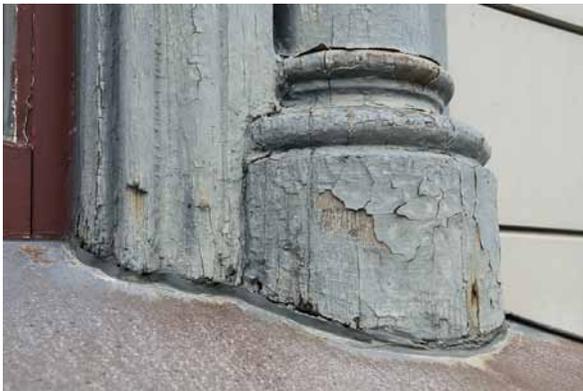
**Photo 19:** The turned bases to the pilasters have developed cracks and weather checking, but the sloped copper cladding on the sill prevents any leaking water.

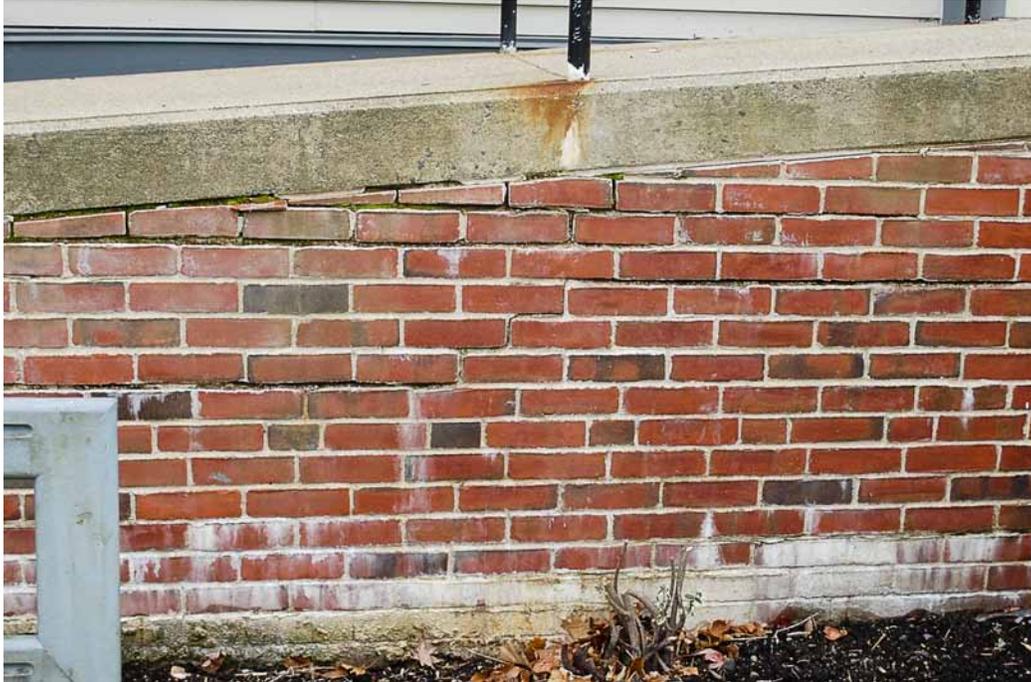
**Photo 22:** Defective mortar joints at the access ramp.

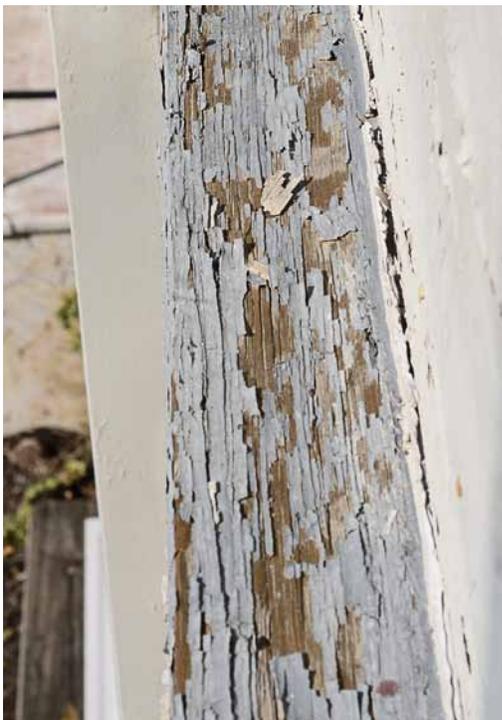
**Photo 25:** Top surface of upper belt course on south side has extensive paint failure and moderate weather checking. A few areas have deeper weather checking. Despite the checking, the wood remains sound and hard, including within the checks.

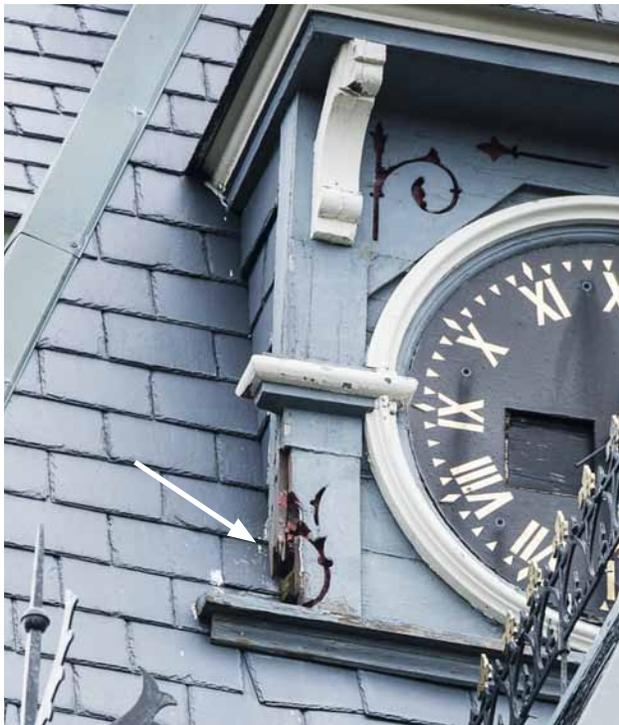
**Photo 30:** Rotted area of wood decoration at the clock tower marked with the white arrow in photo 28. Trim at the other clock faces appears to remain sound.

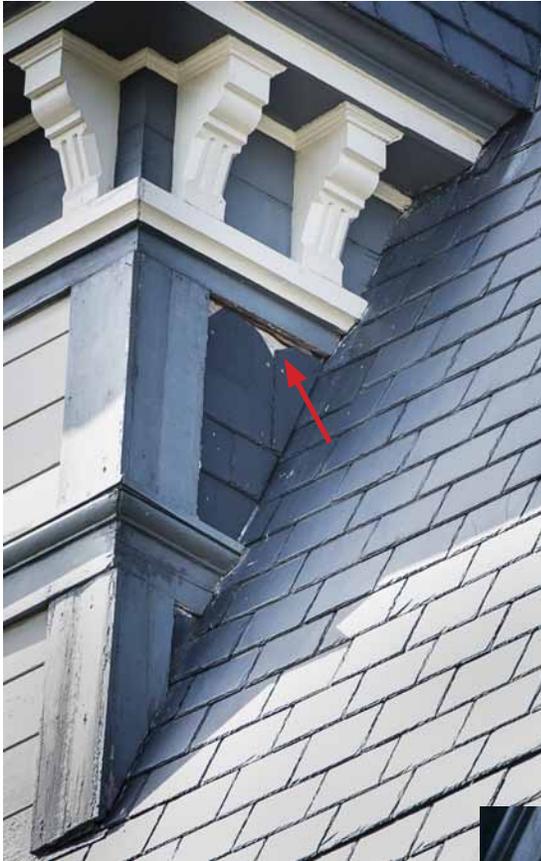
**Photo 31:** Broken slates exposing wood sheathing at the location marked with the red arrow in photo 28. Despite the breaks there do not appear to be any leaks associated with this condition.

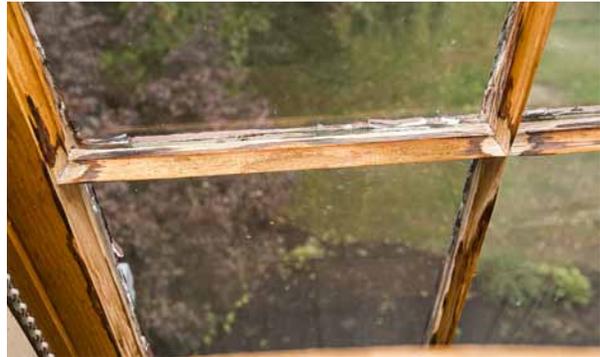
**Photo 35:** Detail of the knife blade profile muntins used on the replacement sash at windows #27 and 38. These windows have never been painted on their interior side.

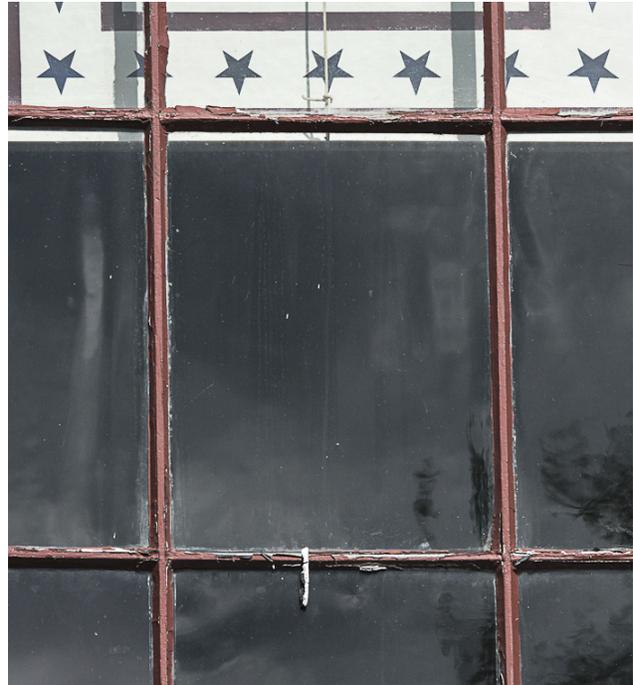
**Photo 40:** Detail of window #36 showing the extensive failure of its glazing compound.

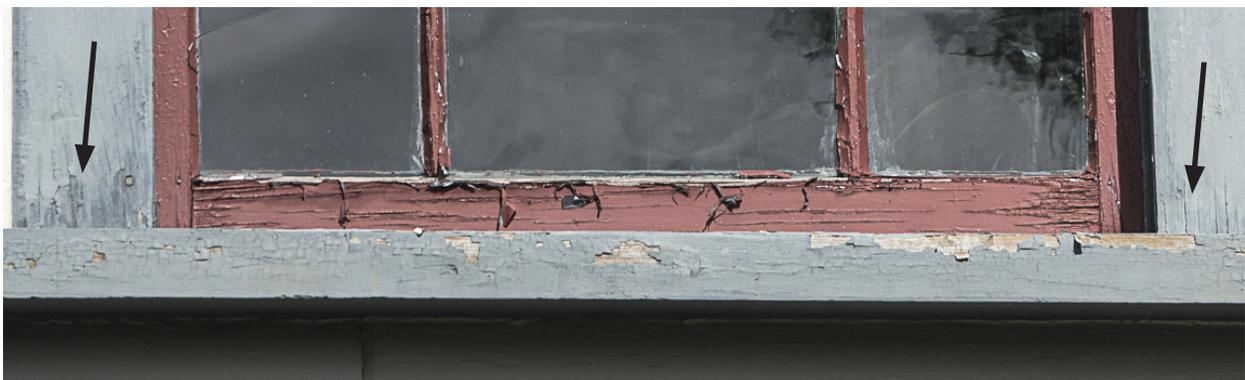
**Photo 41:** Detail of window #36 showing the weather checking of the bottom rail of the lower sash that warrants conservation with epoxy consolidants. The corner joints were found to remain firm. The arrows point to moderate splits at the base of the side casings that can readily be treated with epoxy consolidants. The sill was found to be in sound condition other than peeling paint.

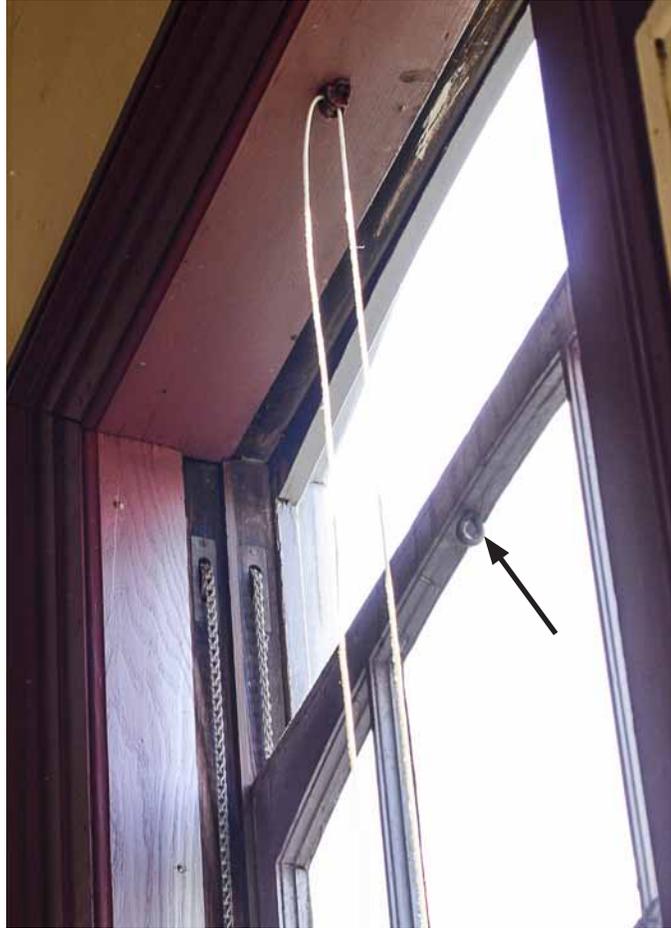
**Photo 43:** Detail of typical type B showing the weight chains and pulleys in good condition for both the upper and lower sash. The arrow points to a metal loop formerly used to operate the upper sash with a long pole. Currently the upper sash are not opened.

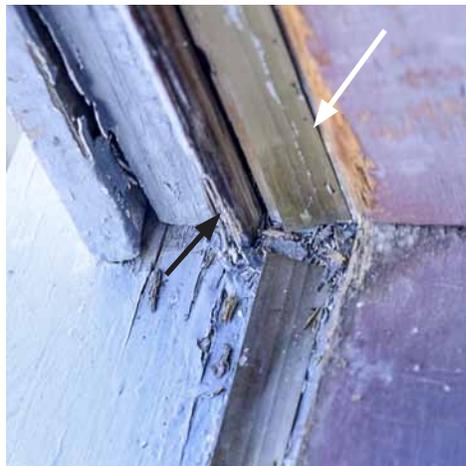
**Photo 44:** Detail of type B window frame at the base of the jamb showing the type of single leaf bronze weatherstripping (white arrow) used at most of the lower sash throughout the building. More robust weatherstripping is needed. The parting bead (black arrow) at this window is worn and needs to be replaced. The spring bronze is also present on this sill, but not at most other sills.

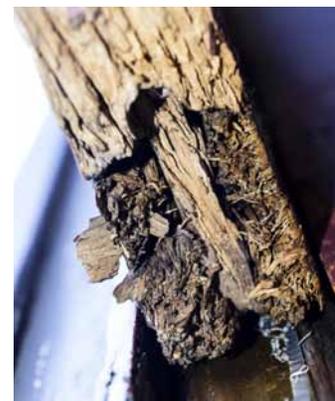
**Photo 45:** Lower corner joint of lower sash at window #29. The base of the stile has rotted off but the tenon of the rail appears to remain intact. Most lower sash corner joints are in better condition.

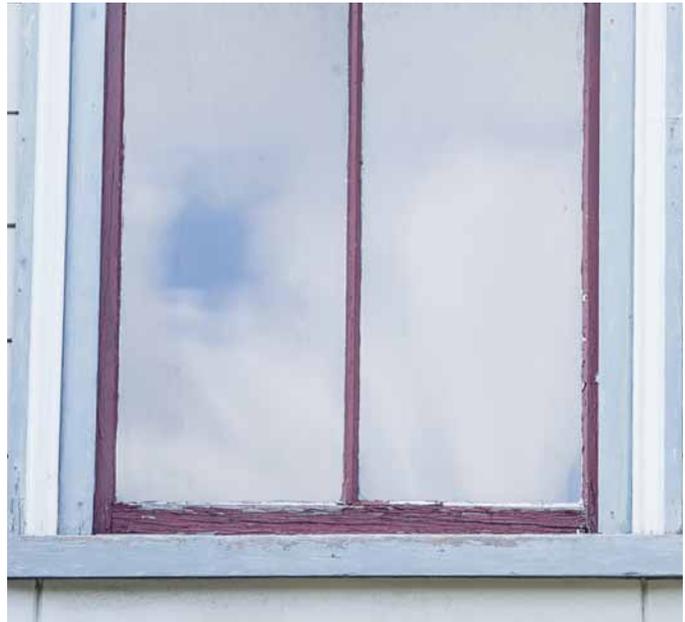
**Photo 47:** Windows #25 (type C) on the front facade. The bottom rail of this window has extensive checking in the bottom rail needing substantial epoxy conservation.

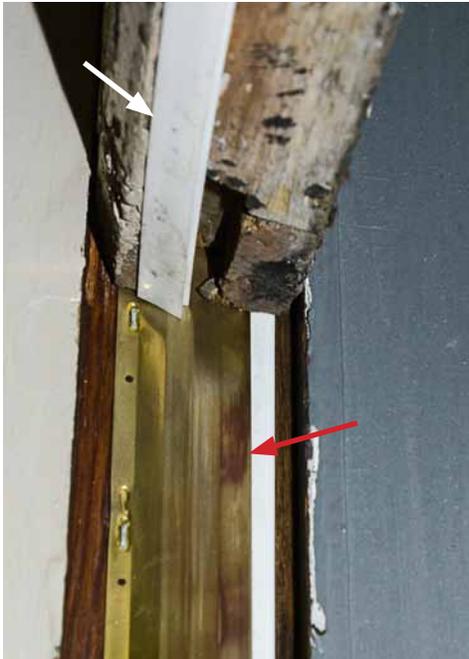
**Photo 53:** Typical weather stripping on the first floor lower sash. The white arrow points to the vinyl leaf used on the underside of the lower rails of the lower sash. The red arrow points to the single leaf spring bronze used in the jambs. Both types are not very effective.

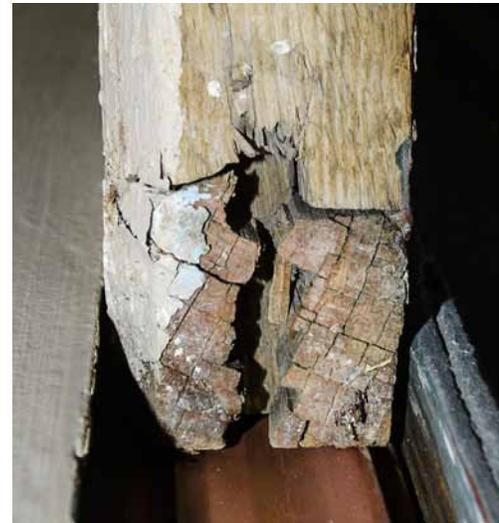
**Photo 54:** Common defect at the corner joint of a lower sash looking up at the bottom of the stile and rail. The joint remains solid, but the portion of the stile that covers the rail tenon has fallen away and the end grain at the bottom of the stile is checked. This condition is easily repaired with epoxy conservation.

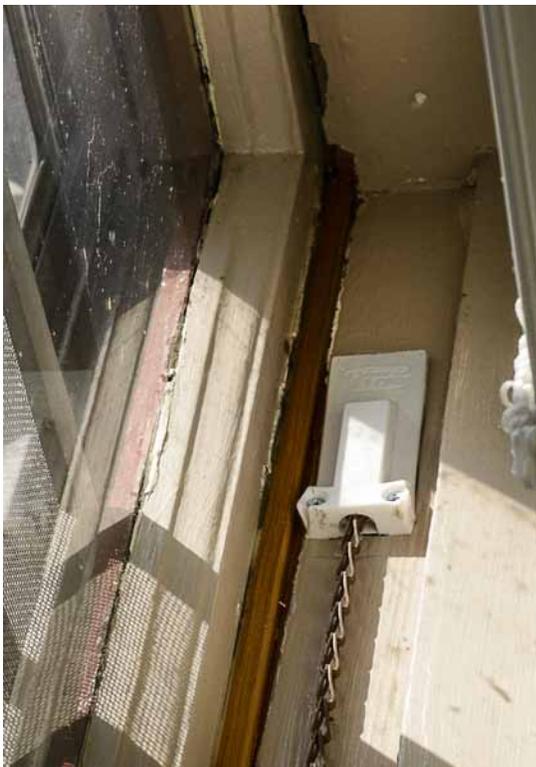
**Photo 55:** A number of the pulleys on the first floor have been replaced with modern pulleys and new chains. While not original, these are serviceable. The parting bead at this window has also been replaced.

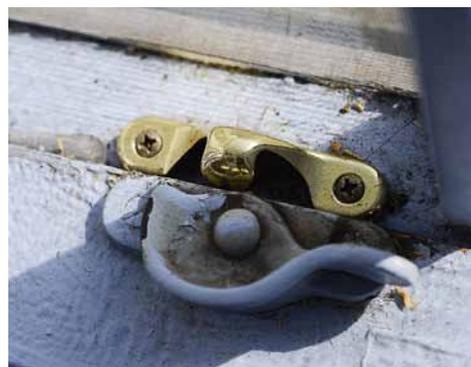
**Photo 57:** Typical modern replacement clam shell type sash lock. In many cases these are not functional due to mis-alignment of the sash, poor mounting, or other problems.

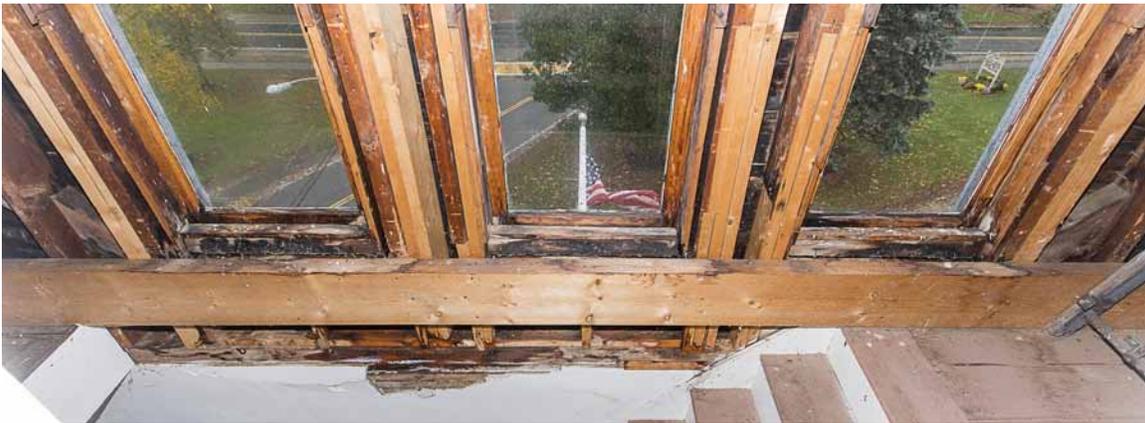
**Photo 59:** Interior of windows # 46, 47, & 48 at the attic. The windows leak badly during periods of prolonged wind driven rain, as evidenced by the stains below them. They have never been painted and also lack proper interior stops. The large beam is from past structural reinforcements to the tower.

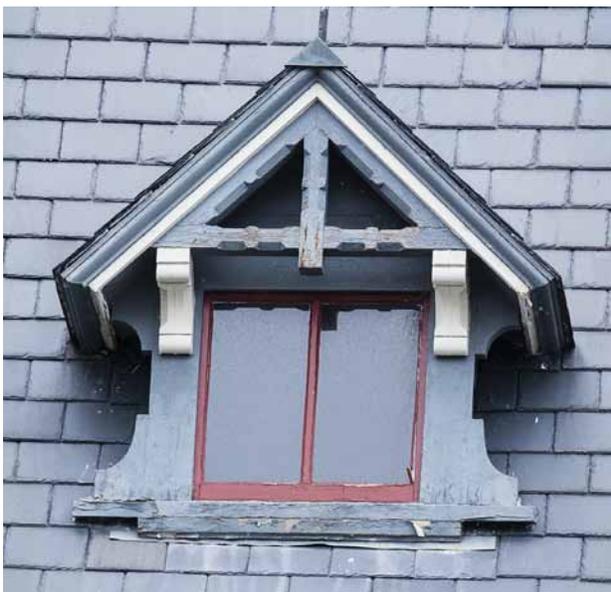
**Photo 60:** Window #50 (type I). The sash is fixed in place and appears to be a fairly recent replacement. The trim appears to be sound other than being badly in need of paint.

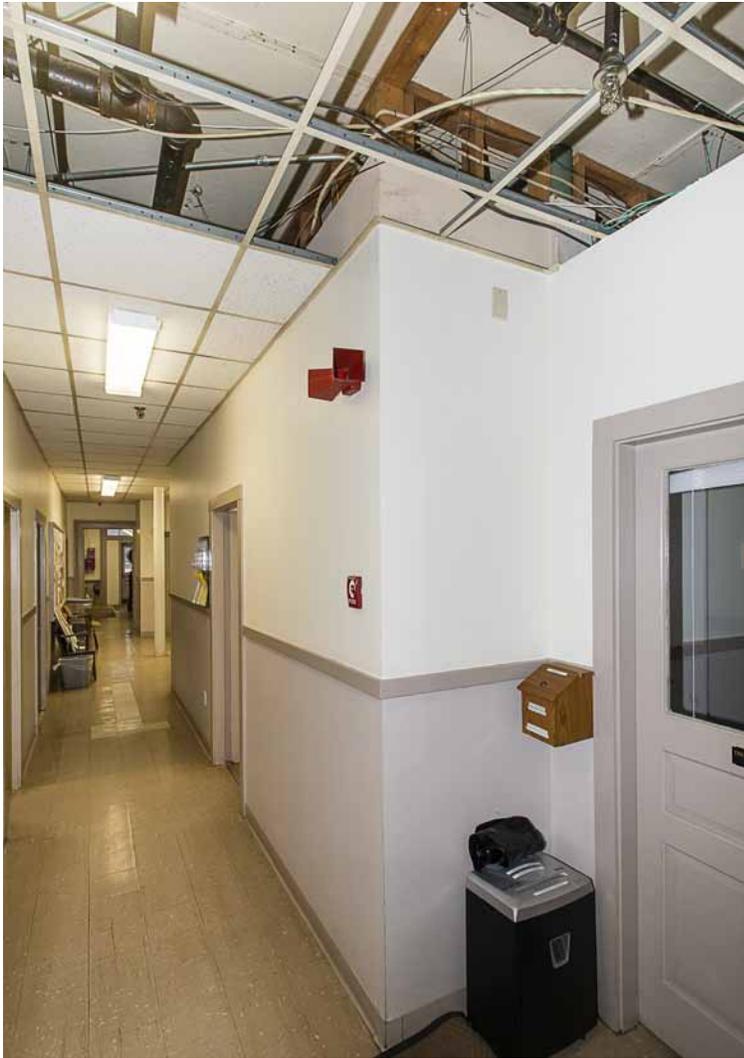
**Photo 63:** The main first floor corridor at its west end looking east towards the front entry. The dropped ceiling panels have been removed to repair a frozen pipe that flooded the treasure's office. The wall framing above the dropped ceiling shows that the corridor walls are of relatively modern construction. The pipes for the sprinkler system are visible above the ceiling panels.

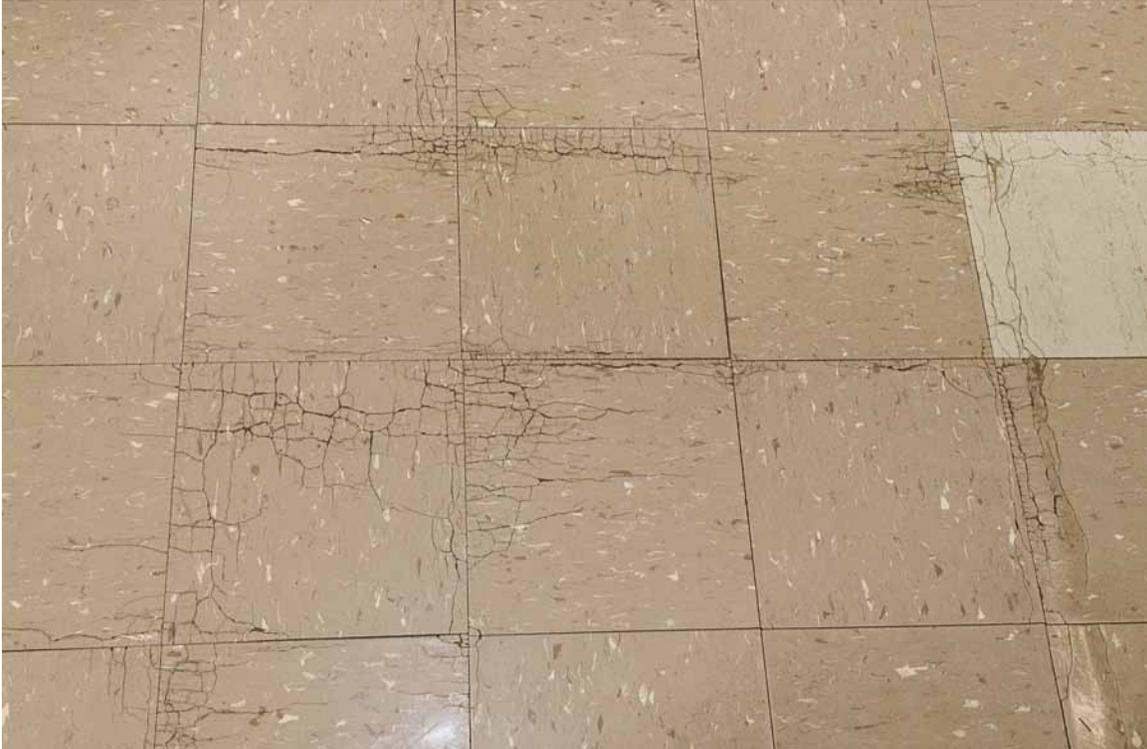
**Photo 65:** Detail of floor tiles that likely contain asbestos that are used throughout the first floor corridors and offices showing their typical deteriorating condition. They are covered with wall to wall carpeting in many of the offices, but the carpeting is also badly deteriorated.

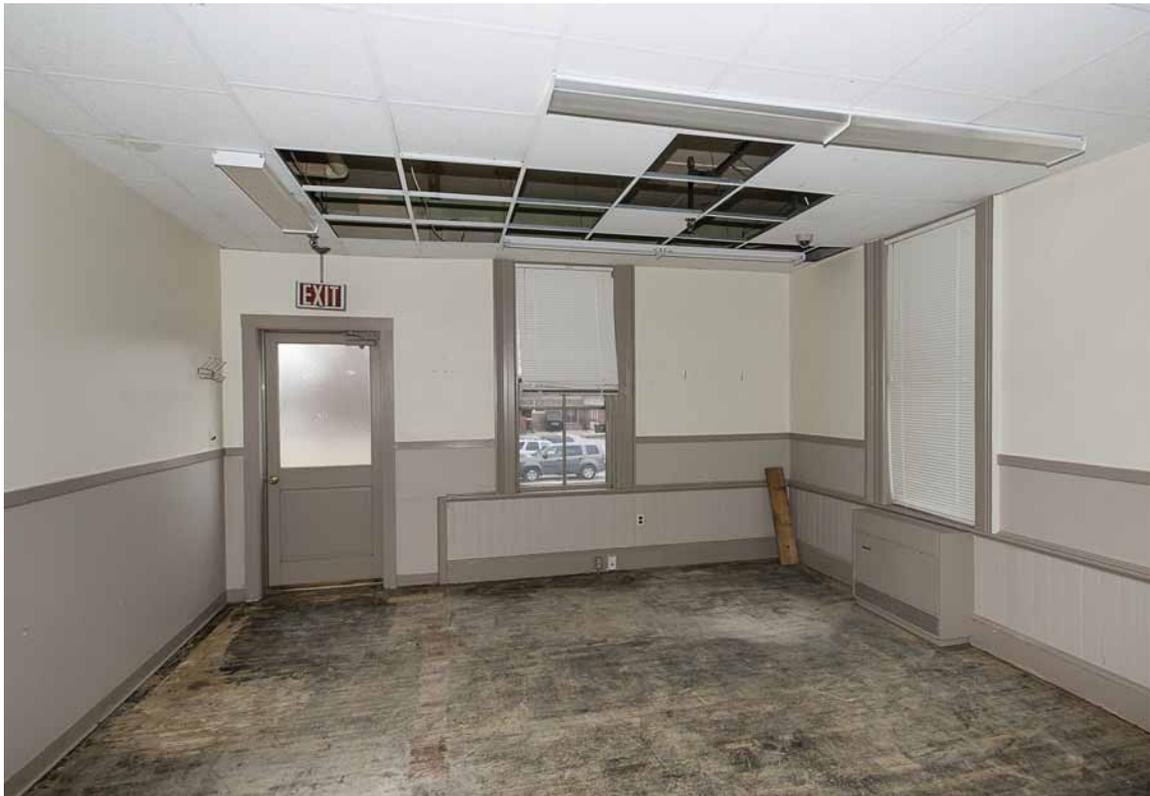
**Photo 70:** The treasurer's office at the southwest corner of the first floor after it was cleared out due to being flooded from a frozen pipe. The vinyl-asbestos tile has been removed showing the original wood floor, and wood wainscot.

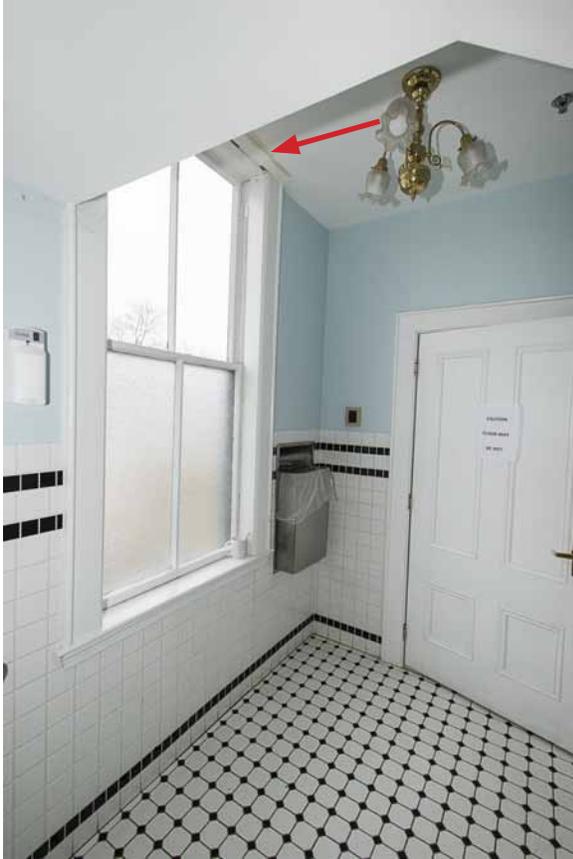
**Photo 71:** First floor bathroom that has been renovated to provide an handicapped accessible bathroom. The water stains above the window (arrow) are from leaks through the badly deteriorated window #32 directly above.

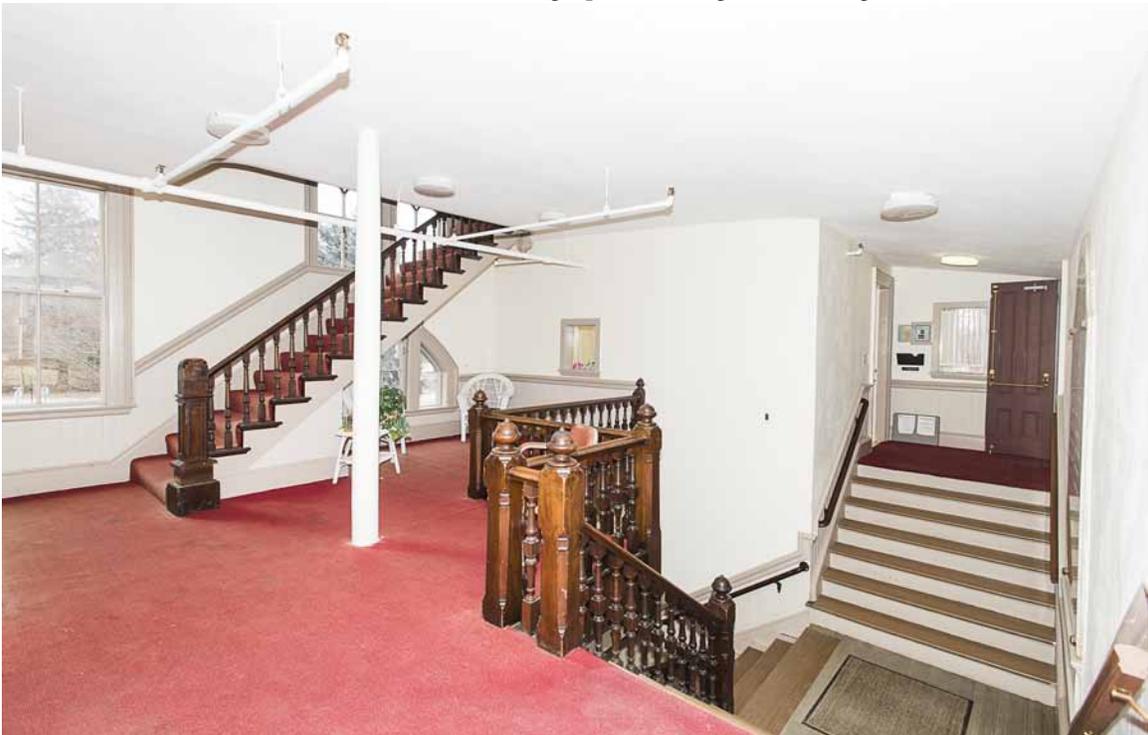
**Photo 74:** Second floor landing of the front stair. The stair in the background leads to the mezzanine of the meeting hall. The door on the extreme right is original and leads into the meeting hall.

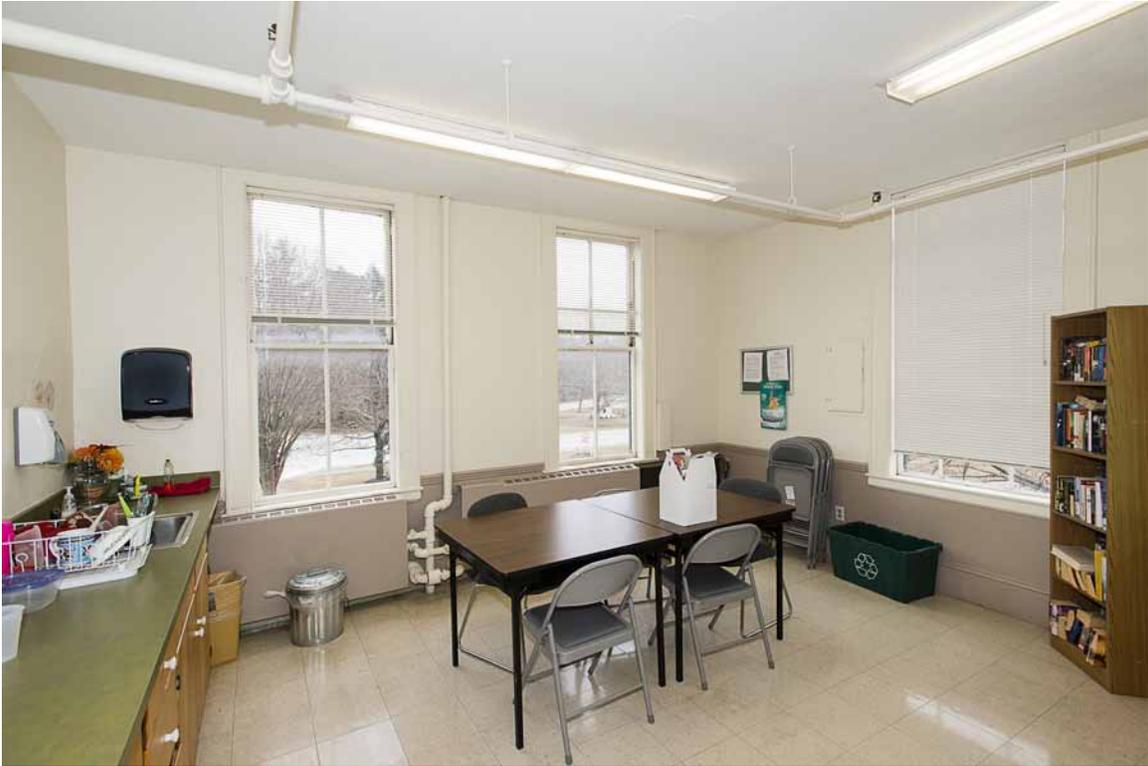
**Photo 75:** Southeast room on the second floor now used as a staff lunch room.

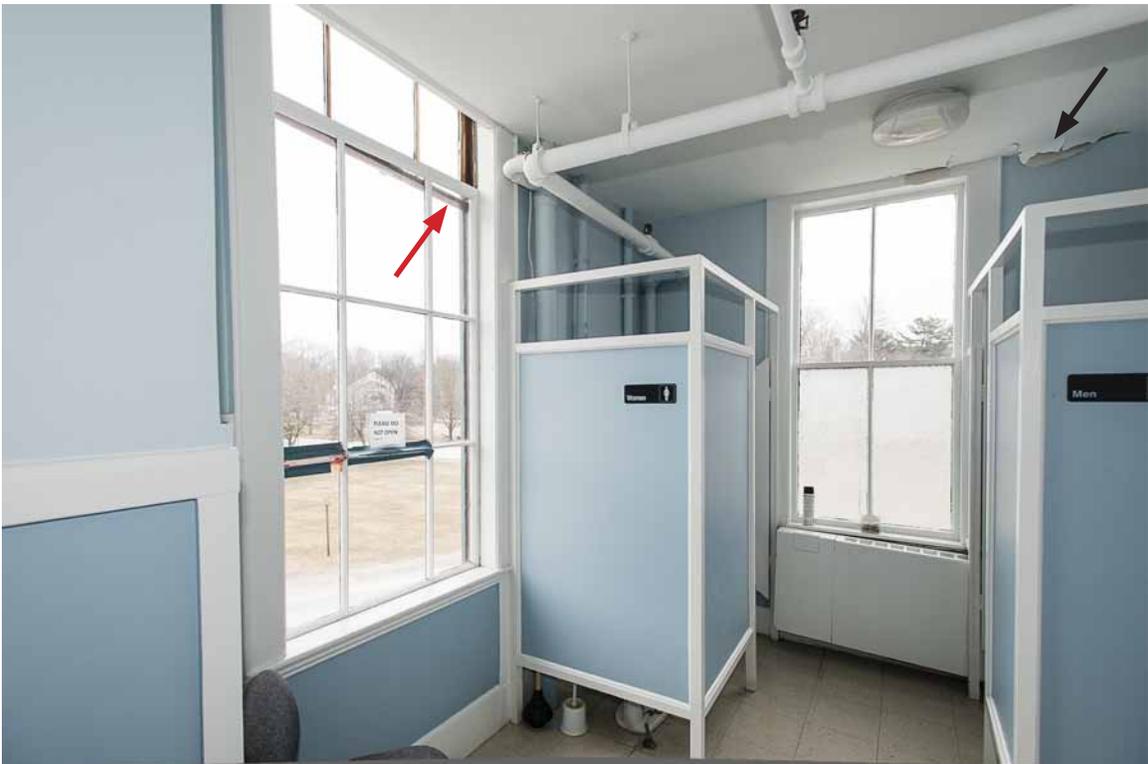
**Photo 76:** Northeast room on the second floor now used as a bathroom. The red arrow points to the upper sash meeting rail which has dropped down substantially from its original position (Window #27). The black arrow points to peeling paint from a past leak that is not believed to be current.

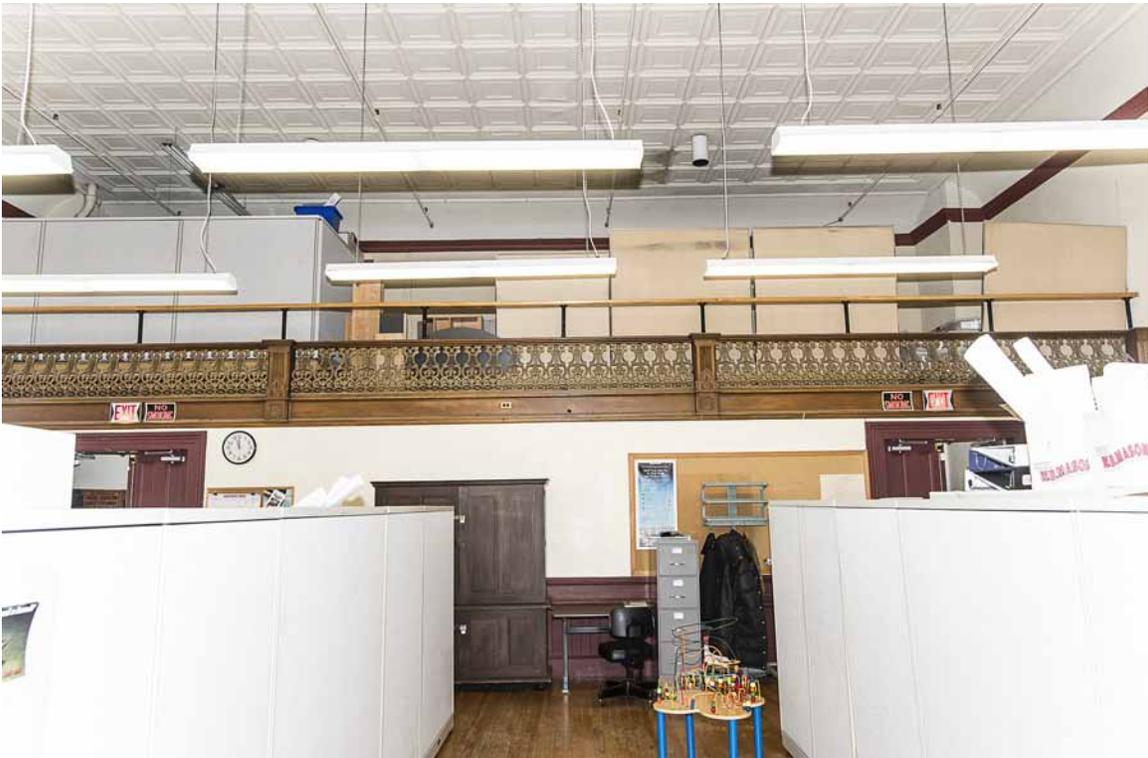
**Photo 78:** The original second floor meeting hall looking east towards the balcony and the front of the building.

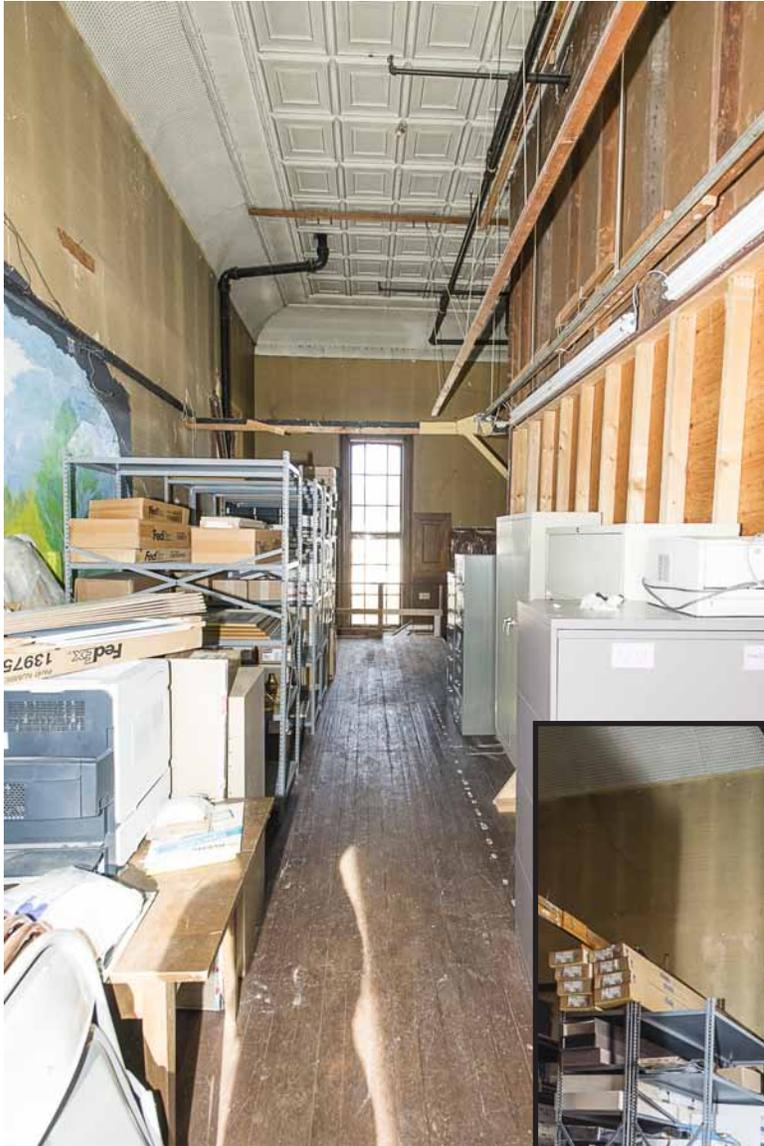
**Photo 79:** The stage area of the meeting hall looking towards window #32 in the north wall. The wall on the right separates the stage area from the main meeting hall. The modern framing on the right is modern framing to close off the stage area, which is several feet above the floor level of the main hall.

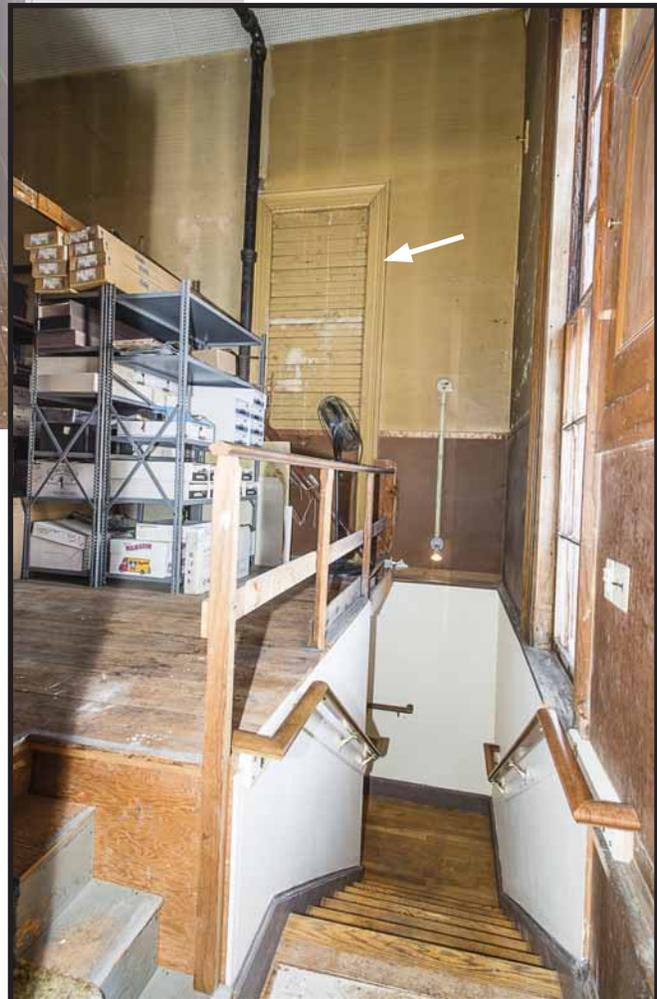
**Photo 80:** Stair at the north end of the stage area has been recently renovated to provide a second egress for the offices in the meeting hall. One of the blind windows in the rear (west) wall is visible in the center of the photo (arrow). It is not known these windows ever contained glazed sash. Window #32 is on the extreme right.

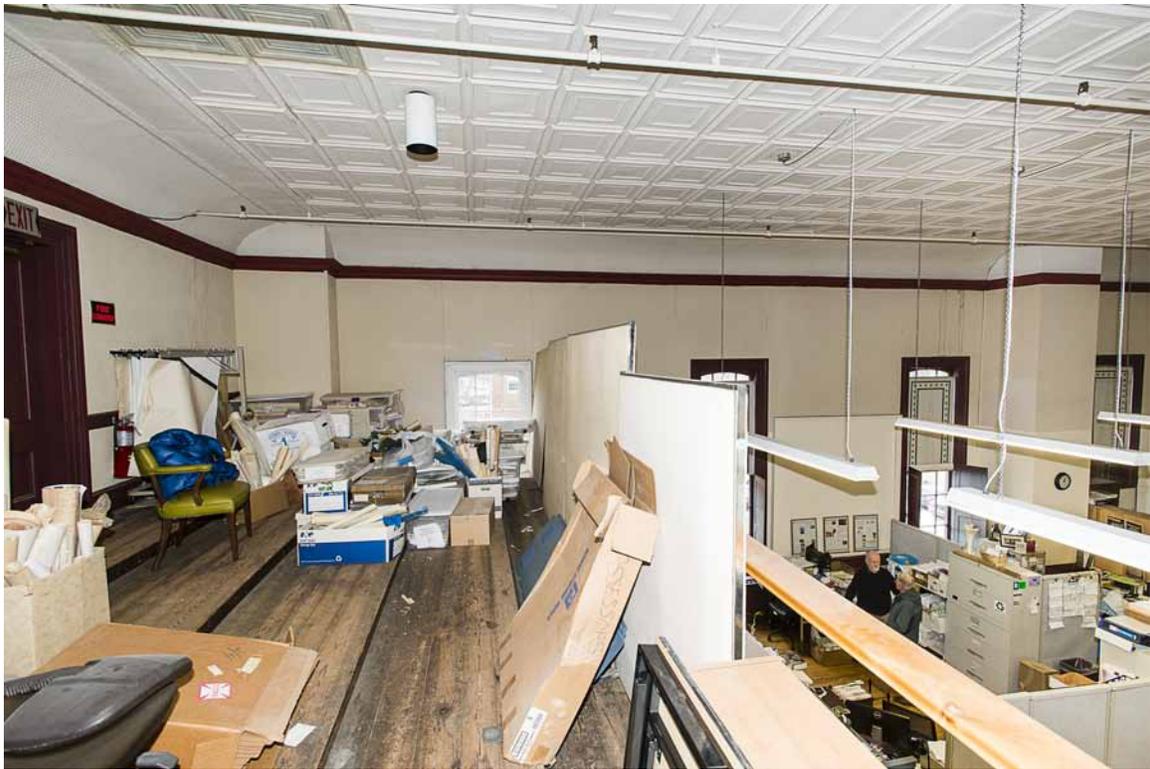
**Photo 81:** Meeting hall balcony looking towards the south wall.

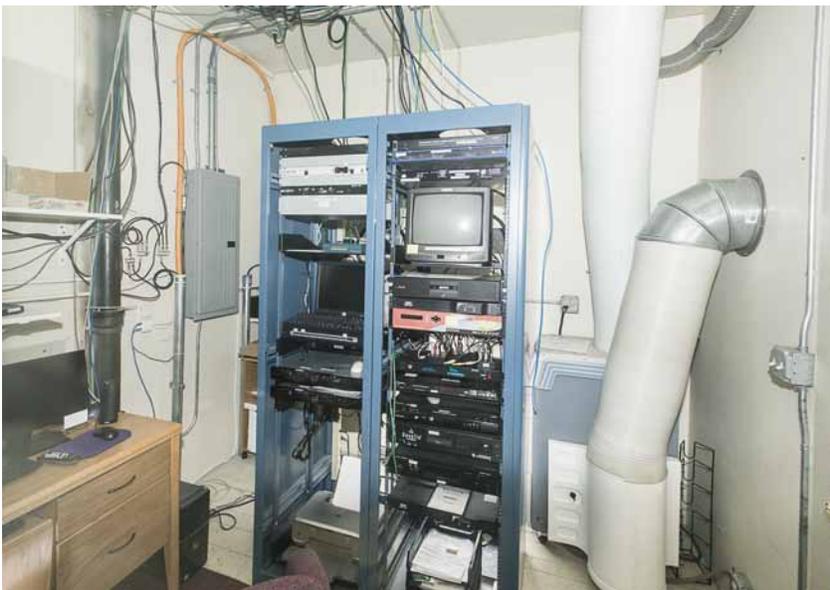
**Photo 85:** Room in the northeast corner of the balcony level that is now used by the local cable station. The room is heavily insulated with new walls inboard of the original walls and kept at a constant temperature with its own HVAC equipment.

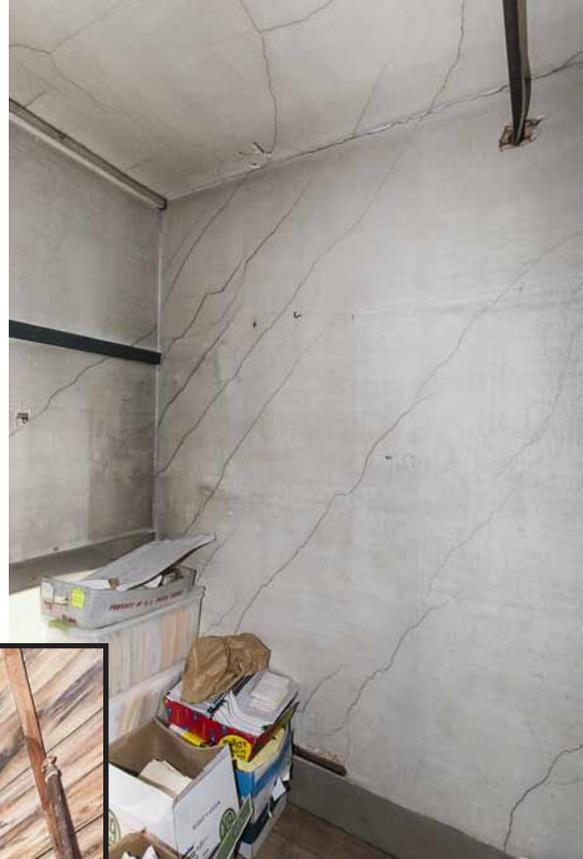
**Photo 86:** Room in the southeast corner of the balcony level that is now used for storage. Its plaster walls have not been painted or otherwise repaired for many years and therefore show the cracks from the long past structural movements of the tower.
