**First Floor Plan - Photograph Locations**  
 Survey of Existing Conditions  
 Topsfield Town Hall  
 Adams & Smith / Finch&Rose  
 Scale: 1/8" = 1' - March 6, 2015

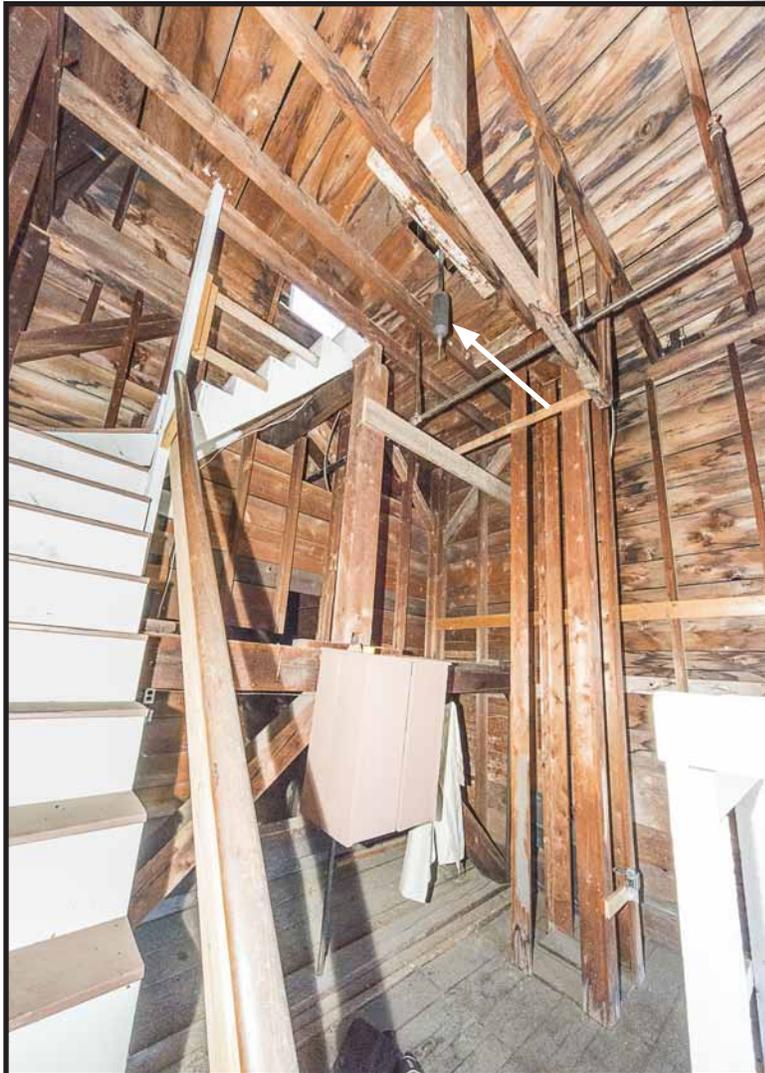
**Photo 87:** Attic level room in the center of the tower. The stairs lead up to the clock room above this space at the top of the central tower. The arrow points to the pendulum for the tower clock.

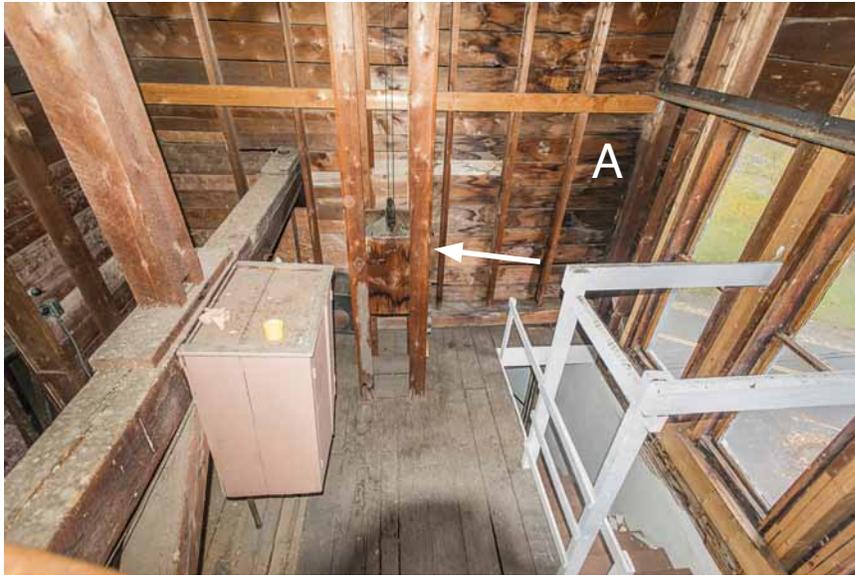
**Photo 88:** Attic level room in the center of the tower. Windows # 46, 47, & 48 are on the right. The arrow points to the weight for the tower clock located directly above this space. "A" marks the wall that is also marked "A" in photo 87 below.

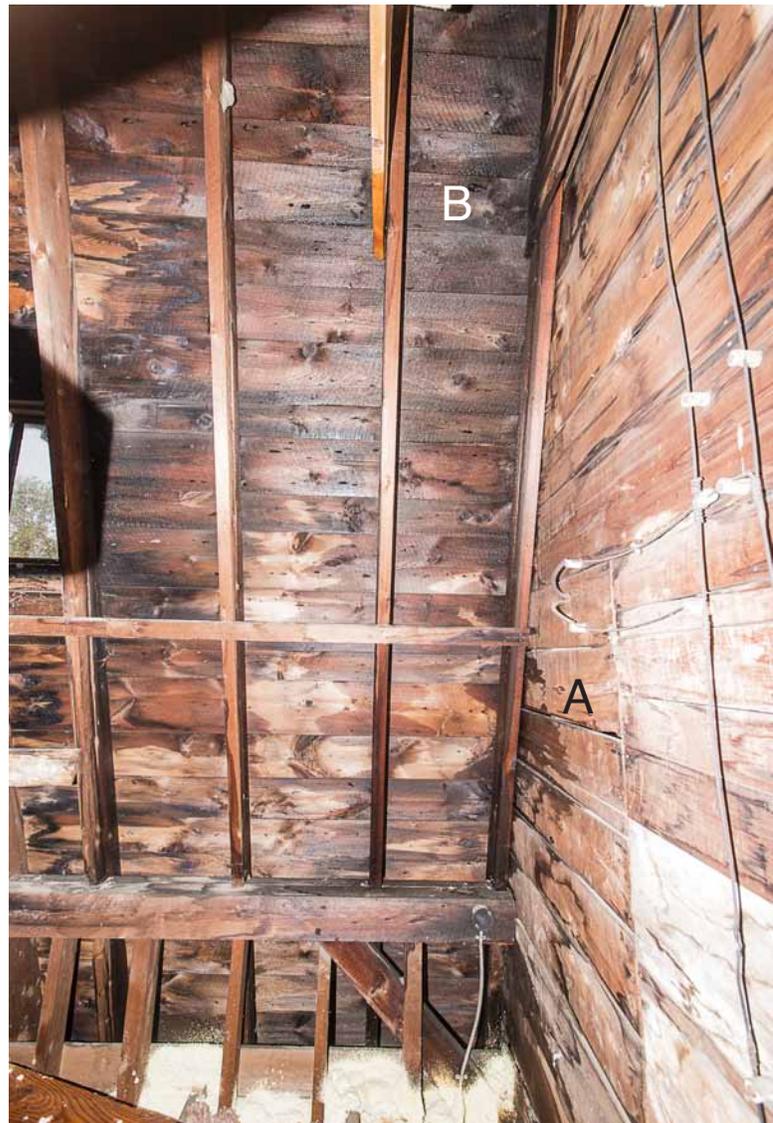
**Photo 89:** Attic space on the north side of the center tower room looking at the sheathing on the front pitch of roof. The window at the extreme left is #50. "A" marks the board wall that forms the north side of the center tower attic room. The photo was taken immediately after 2 days of heavy rain with very strong northeast winds that resulted in the water penetration in the area marked "B" above, as well as at the right side of the dormer. This leaking is believed to be from the worn closed valley flashings shown in photo 29. A relatively small amount of the water was visible on the wall marked "A" in photo 86. Water from these leaks does not appear to be penetrating to finished spaces in the floors below, perhaps because the base of the roof is corbeled out from the front facade below. These same areas were examined on another day following a day long period of heavy rain without strong winds. No leaks were visible at that time. It appears that these leaks only occur a few times a year during long periods of extremely heavy rain driven by strong northeast winds (northeasters or hurricanes), and do not appear to be causing substantial damage.

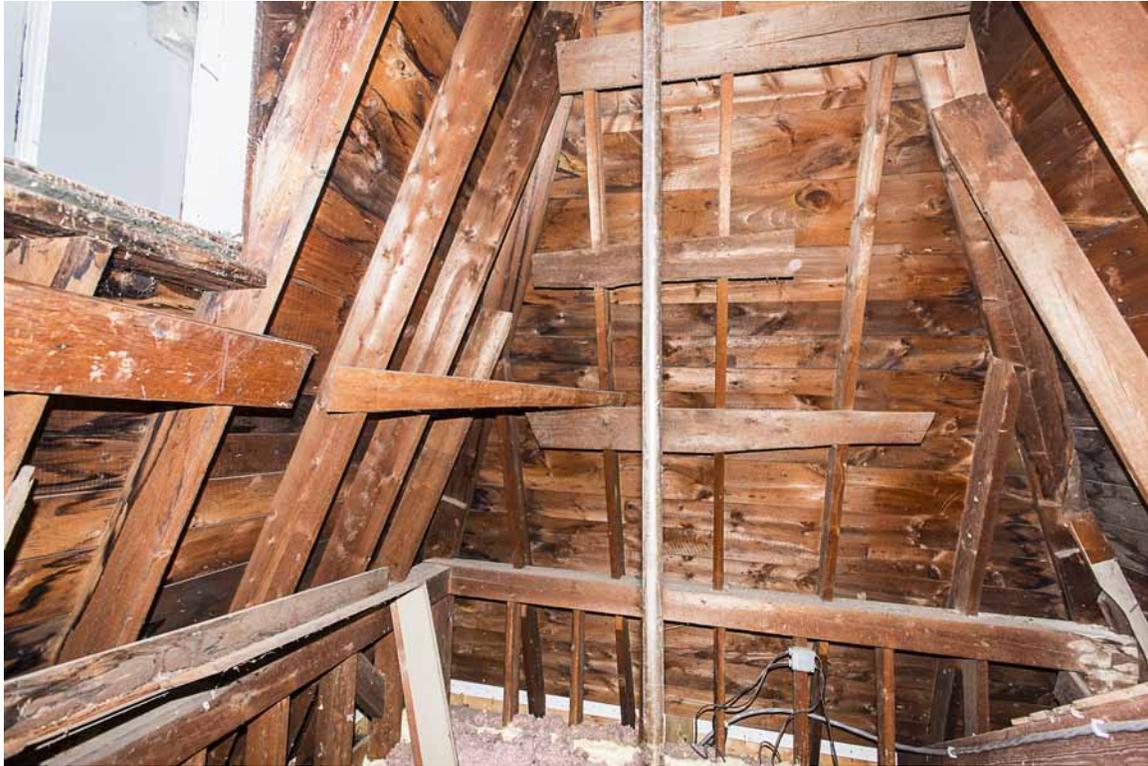
**Photo90:** Attic space on the south side of the center tower room looking at the sheathing on the south pitch of roof. The sheathing on the left is the front (east) pitch of the roof.

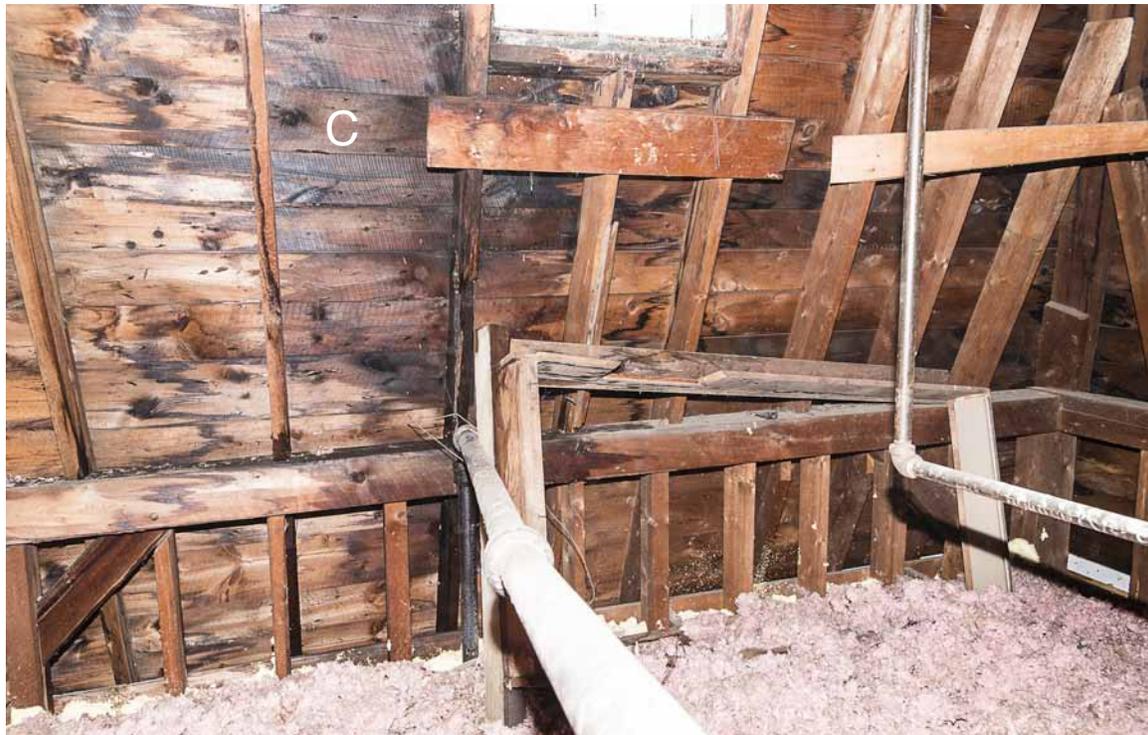
**Photo 91:** Attic space on the south side of the center tower room looking at the sheathing on the front (east) pitch of the roof with window #49 in the upper center. This photo was taken the same day as #87. The wet area at "C" is from the flashings on the east side of the dormer roof of window #49. Like the leaks in photo 89, they only occur a few times a year and do not appear to be affecting the floors below.

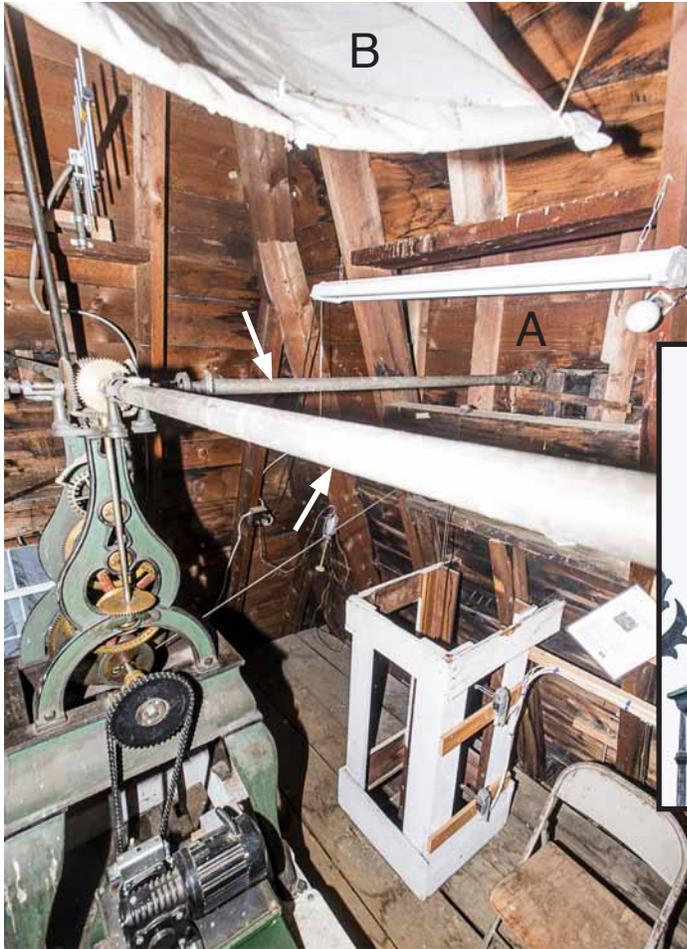
**Photo 92:** Top level of clock tower with clock mechanism on lower right. The arrows point to the shafts linking the clock movement to the clock faces. “A” marks the interior of the northerly clock face. “B” marks a sheet of plastic that has been set up to protect the clock mechanism from occasional leaks from coming the top of the tower.

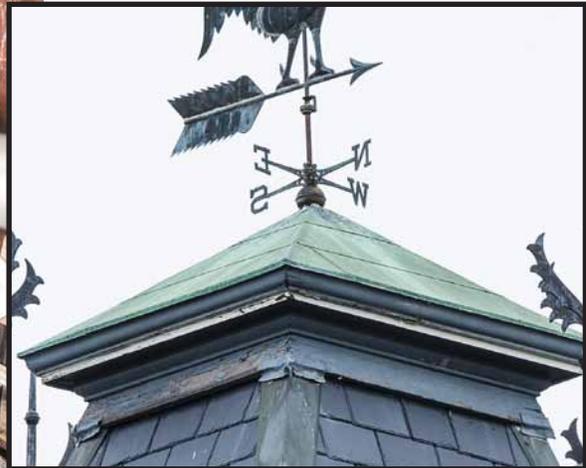
**Photo 93:** Top of clock tower and base of weathervane. The penetration of the weathervane shaft is a likely source of the leaks in photo 94, but there may be other defects in the copper roof and cornice woodwork.

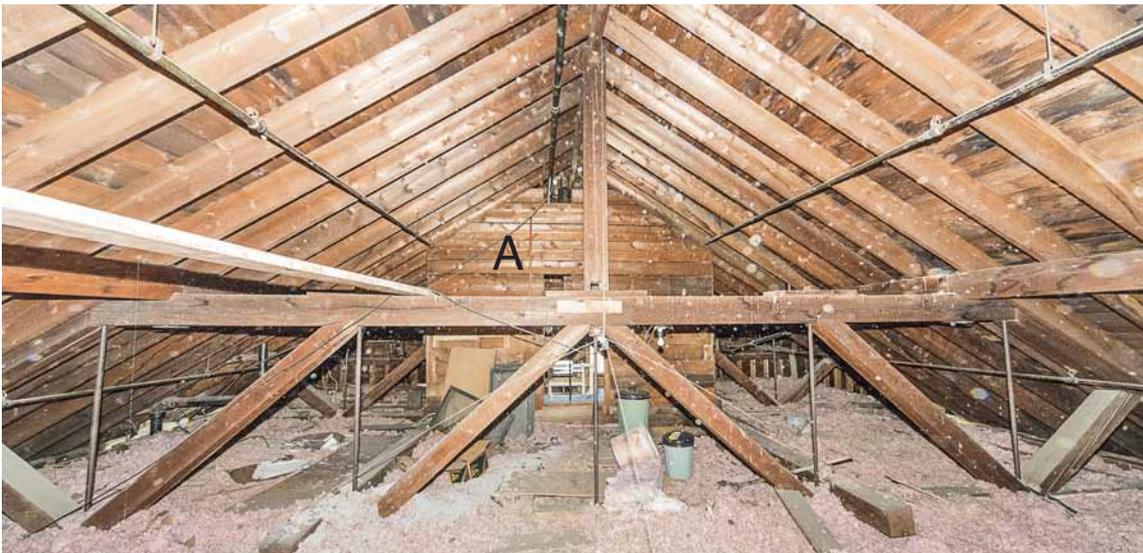
**Photo 96:** Attic and roof framing under the main roof looking east towards the front of the building. The room at the front of the tower shown in photos 87 and 88 is behind the partition marked "A".

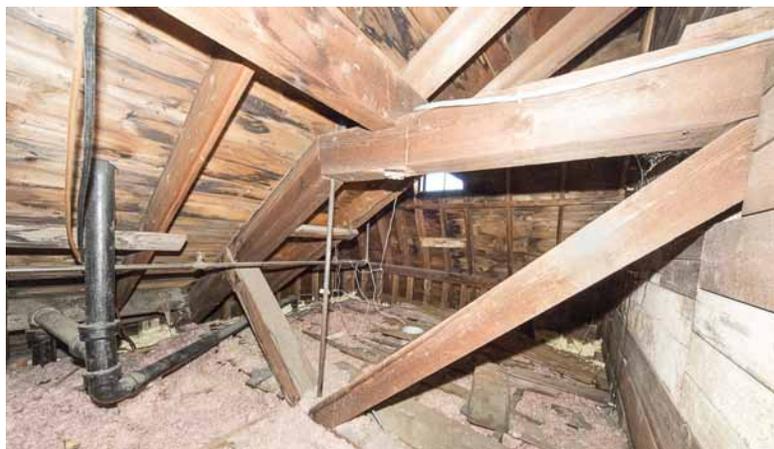
**Photo 97:** Attic looking east into the space at the northeast front corner shown in photo 87 (the space is to the left of the partition marked "A" in photo 94 above).

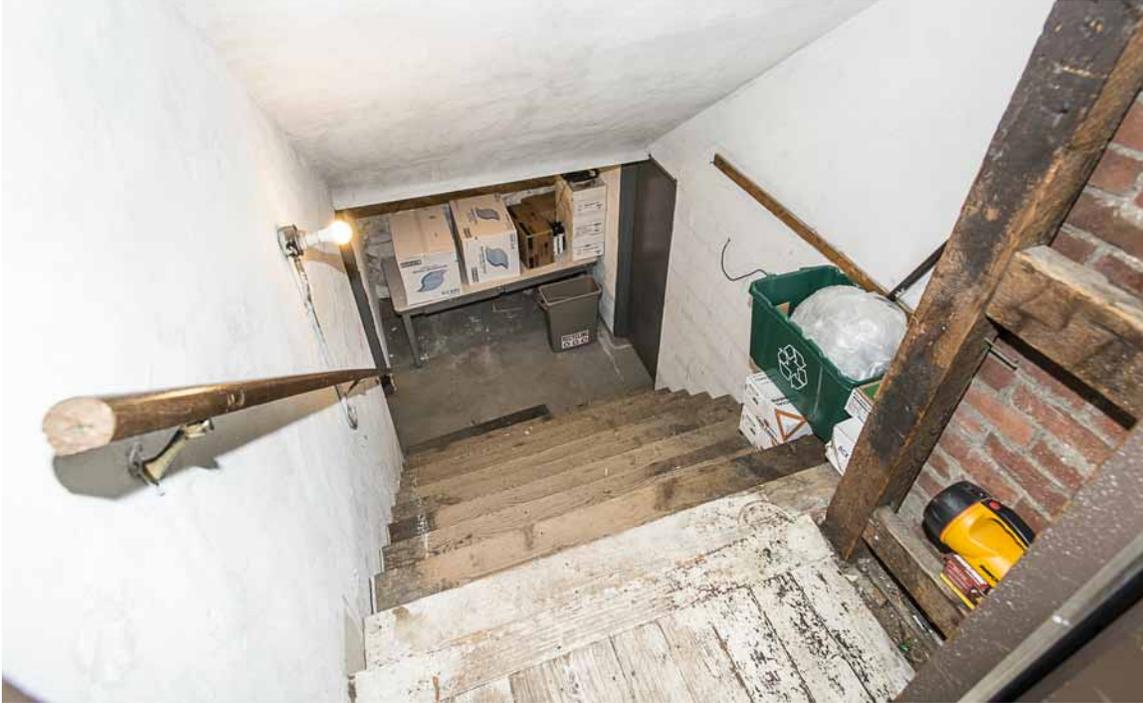
**Photo 98:** Stairs leading down to the basement. These stairs are located directly below the main front stairs.

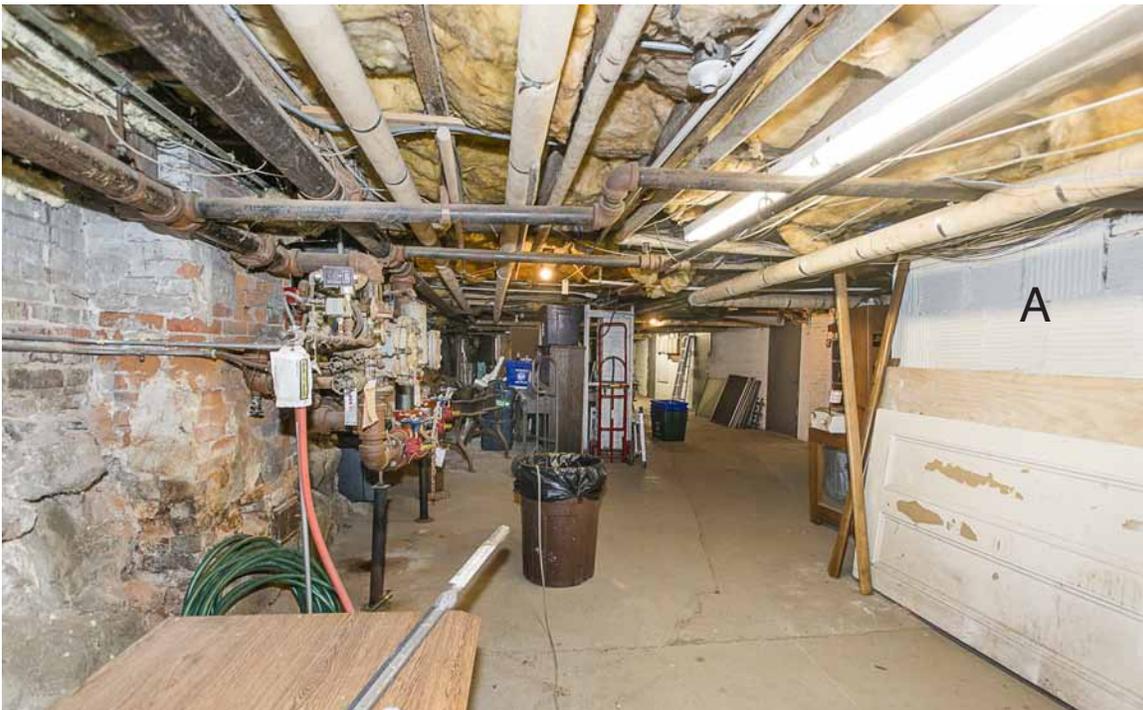
**Photo 99:** Basement looking east towards the front of the building. The north side foundation wall is on the left. The ceiling has been insulated with fiberglass batts. "A" marks a terra cotta block wall that encloses storage rooms and some utilities. Although concerns have been expressed that mold is present in the basement from past leaks and basement dampness, no evidence of current mold was observed. The exposed fiberglass presents some risk of airborne fiberglass particles, and also could conceal unknown deterioration of the framing. The pipes are insulated with foam.

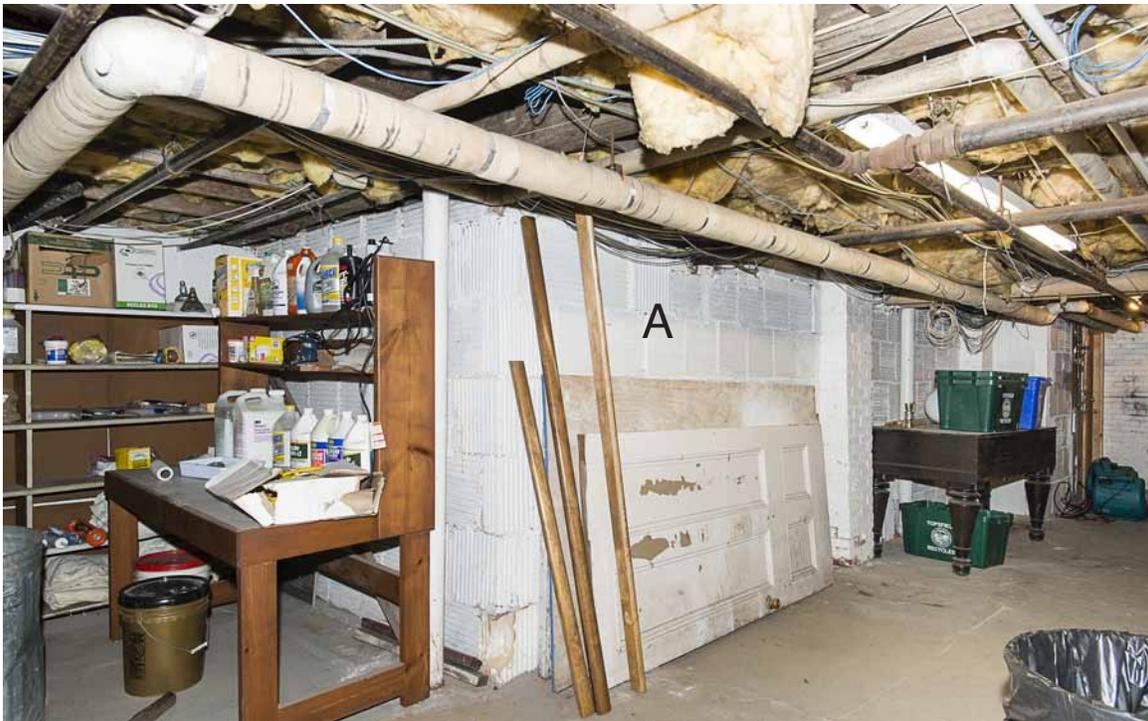
**Photo 100:** Basement looking southwest with the rear wall at the extreme left of the photo. "A" marks the same terra cotta block partition marked in photo 99 above.

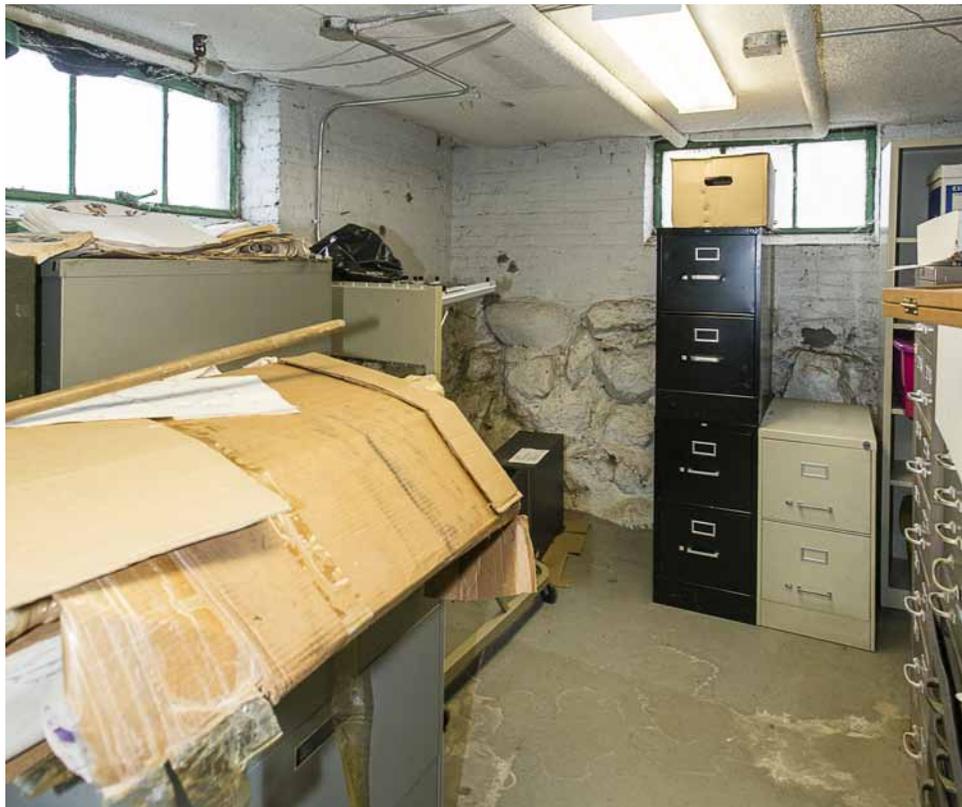
**Photo 101:** Southwest corner of basement showing typical document storage use. The brick portion of the foundation wall is above grade. The south wall is on the left. Some water stains are visible on the floor from past dampness.

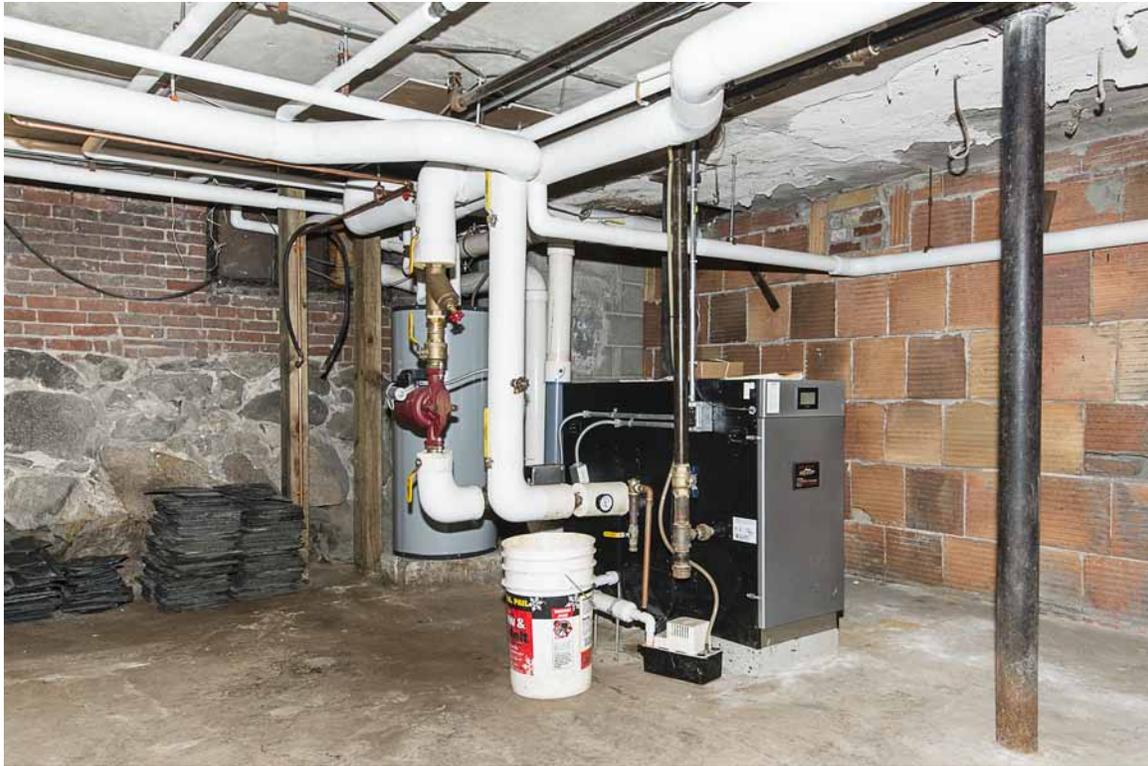
**Photo 104:** Recently installed boiler. The south facade foundation is on the left.

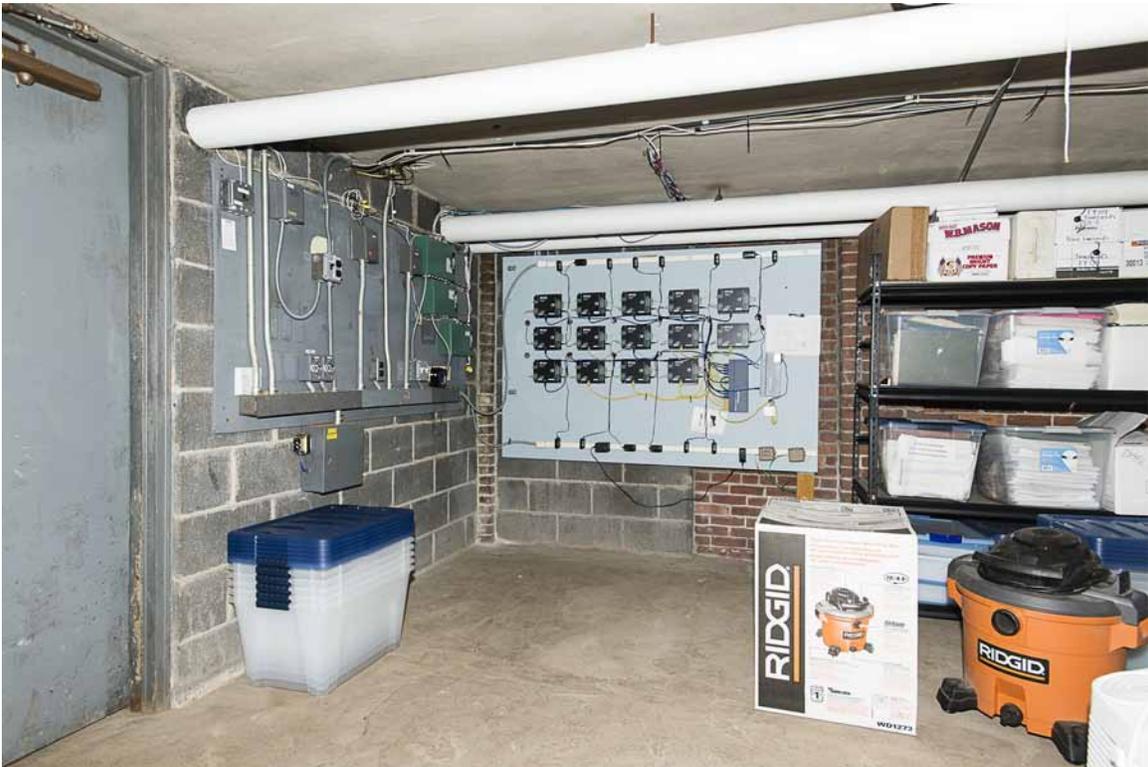
**Photo 105:** Recently upgraded communication panel in the basement. Typical records storage is on the right.
