TOWN BUILDING ASSESSMENT STUDY AND CAPITAL MASTER PLAN  
Town of Topsfield, Massachusetts

**Park & Cemetery**

Pine Grove Cemetery, Haverhill Road.

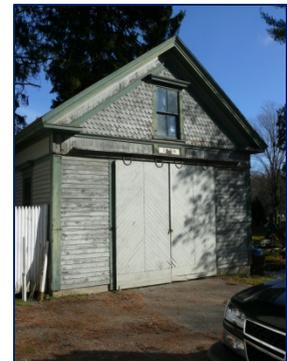
- 2 Windows should be restored and interior storm panels added (including attic windows). (116)
- 2 Exterior should be scraped and painted. Any severely water damaged shingles or siding should be replaced. (79)

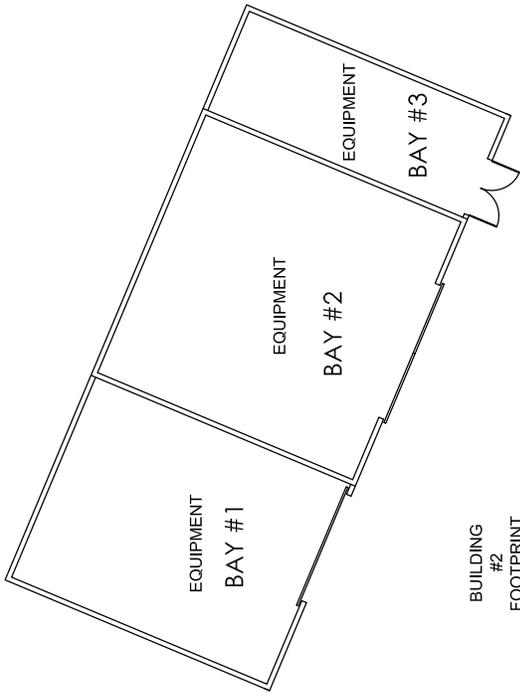
BUILDING #2 FOOTPRINT

Building 2 has two wood framed wings, without floors, that are constructed on concrete piers. These spaces are damp and not appropriate for the storage of equipment.

A new eight bay garage should be constructed to house the four trucks and small equipment, including plows, currently stored in the container and in the wood wings of Building 2.

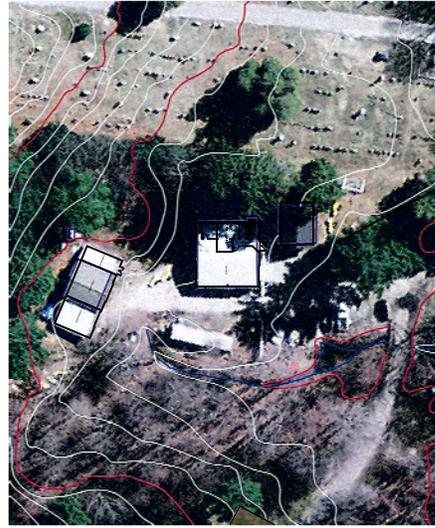
BUILDING #1 FOOTPRINT

Building 1 is the main building and includes the office areas, restrooms and garage space. This is the building that families need to visit to purchase cemetery lots and is not appropriate for this function.

Office areas together with a small conference room should be relocated to Building 3. A link should be constructed to connect Building 3 to Building 1 for access to the restroom. The link could also be used as a waiting area. Steps should be provided at rear door of building 3 and a handicapped ramp with railings added to the side door. Building 3 should be insulated and a hatch created to separate the attic from the main space. Soffit and ridge vents should be added. Perimeter if building 3 is un-insulated; excavate block foundation and install 2 inch thick rigid insulation board to 3 feet below grade.
