First Floor Plan - Photograph Locations
 Survey of Existing Conditions
 Topsfield Town Hall
 Adams & Smith / Finch&Rose
 Scale: 1/8" = 1' - March 6, 2015

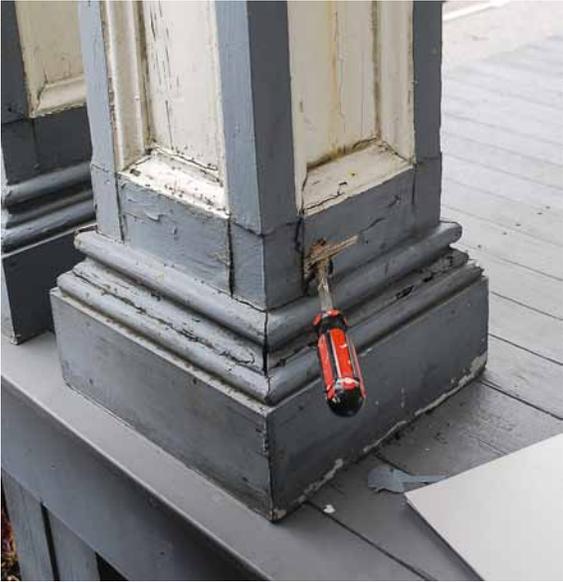
Photo 9: Some of the trim on the lower portions of the columns are rotting.

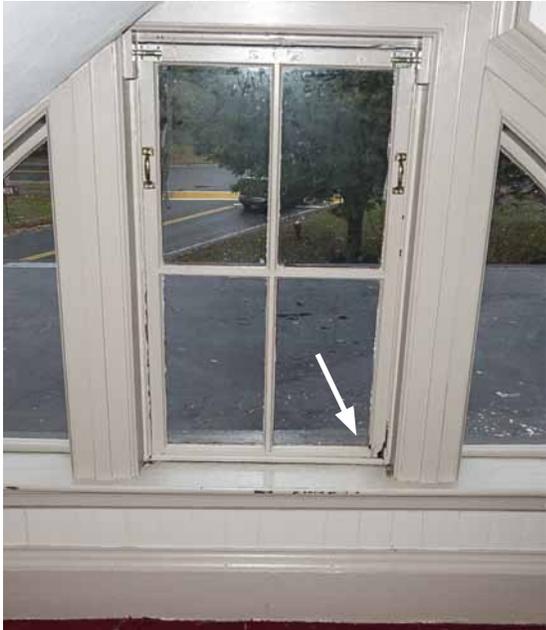
Photo 14: Interior side of window 23, which is removable from the interior to access the entry porch roof. The arrow points to its severely rotted lower corner.

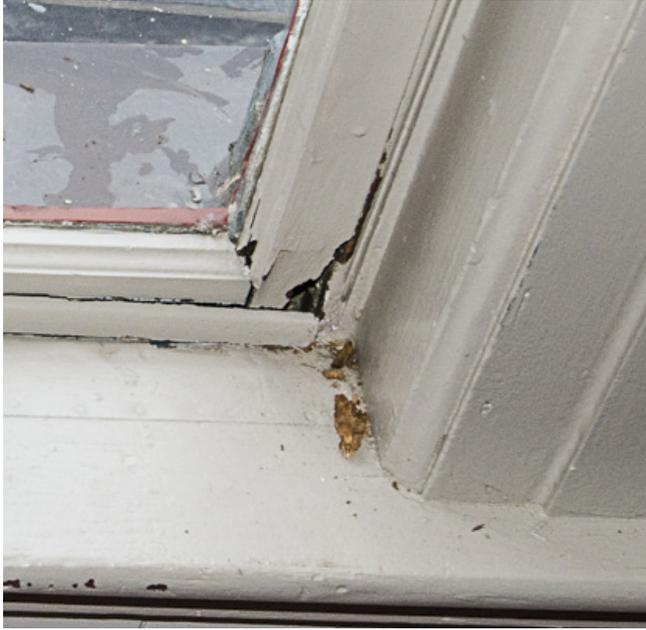
Photo 15: Detail of window 23 showing its badly rotted lower corner. The rot seems to be from a combination of water running down its stile and leaks from the turned base shown in Photo 13.

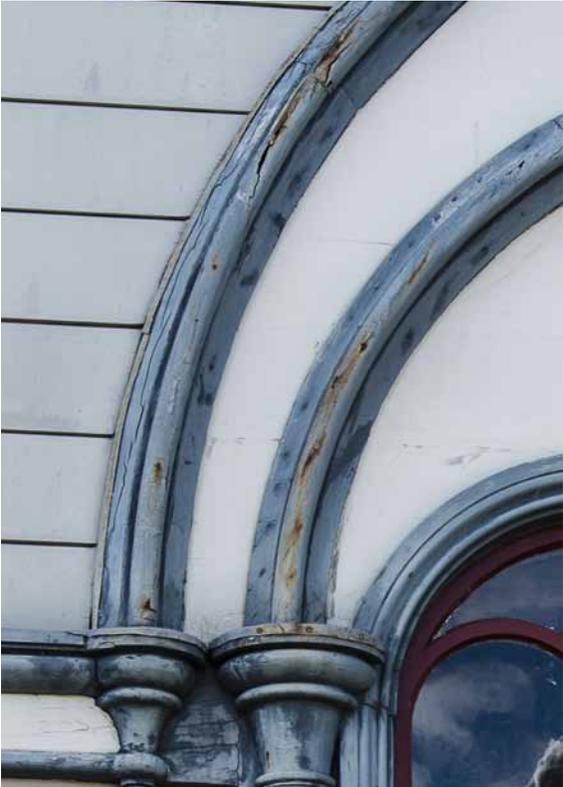
Photo 18: Arched trim above window 42 has substantial cracks, probably started by rusting nails. The outer trim is substantially worse than the inner one. The turnings below the trim appear to be sound and are capped with copper.

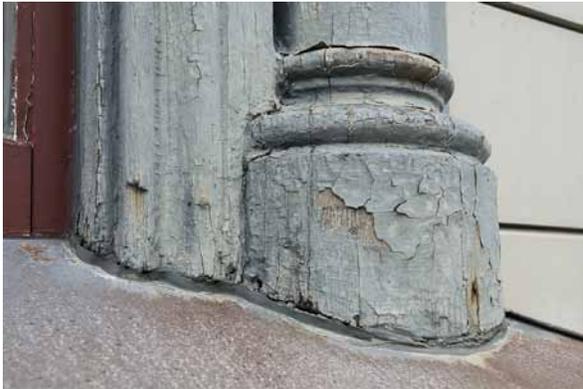
Photo 19: The turned bases to the pilasters have developed cracks and weather checking, but the sloped copper cladding on the sill prevents any leaking water.

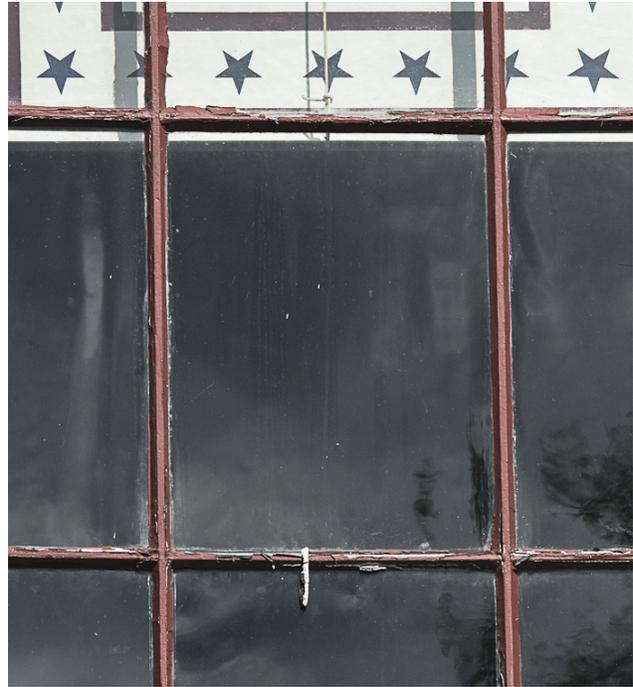
Photo 40: Detail of window #36 showing the extensive failure of its glazing compound.

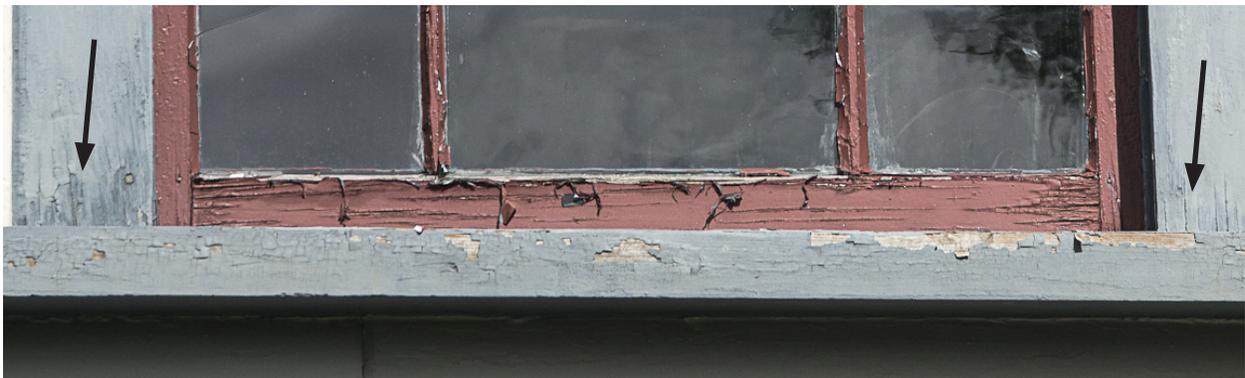
Photo 41: Detail of window #36 showing the weather checking of the bottom rail of the lower sash that warrants conservation with epoxy consolidants. The corner joints were found to remain firm. The arrows point to moderate splits at the base of the side casings that can readily be treated with epoxy consolidants. The sill was found to be in sound condition other than peeling paint.

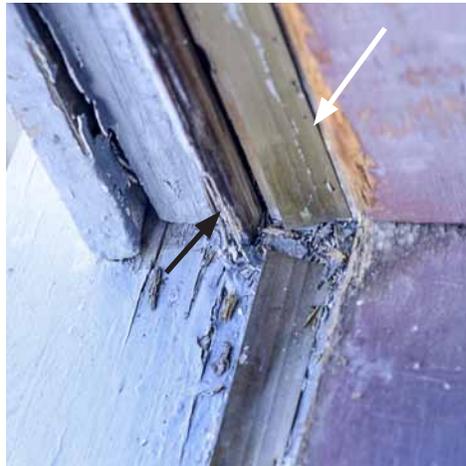
Photo 44: Detail of type B window frame at the base of the jamb showing the type of single leaf bronze weatherstripping (white arrow) used at most of the lower sash throughout the building. More robust weatherstripping is needed. The parting bead (black arrow) at this window is worn and needs to be replaced. The spring bronze is also present on this sill, but not at most other sills.

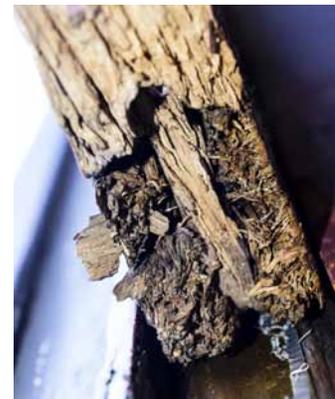
Photo 45: Lower corner joint of lower sash at window #29. The base of the stile has rotted off but the tenon of the rail appears to remain intact. Most lower sash corner joints are in better condition.

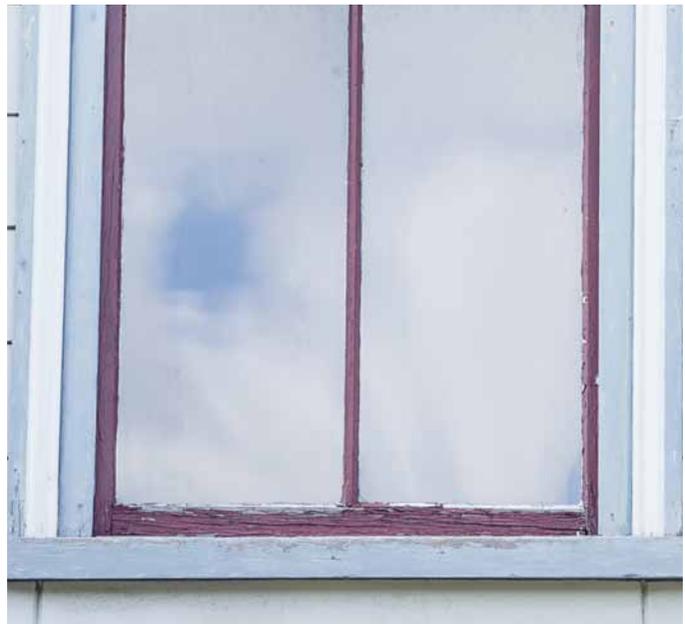
Photo 47: Windows #25 (type C) on the front facade. The bottom rail of this window has extensive checking in the bottom rail needing substantial epoxy conservation.

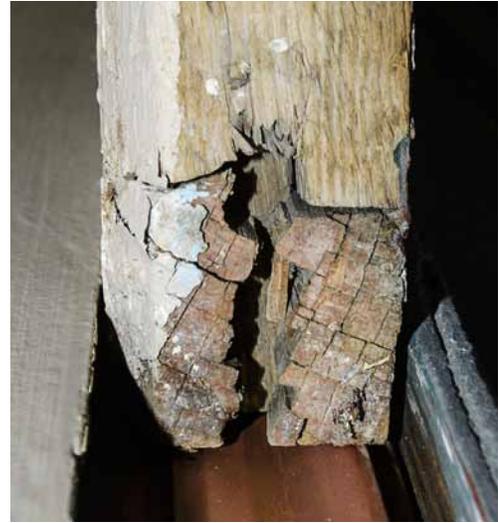
Photo 54: Common defect at the corner joint of a lower sash looking up at the bottom of the stile and rail. The joint remains solid, but the portion of the stile that covers the rail tenon has fallen away and the end grain at the bottom of the stile is checked. This condition is easily repaired with epoxy conservation.

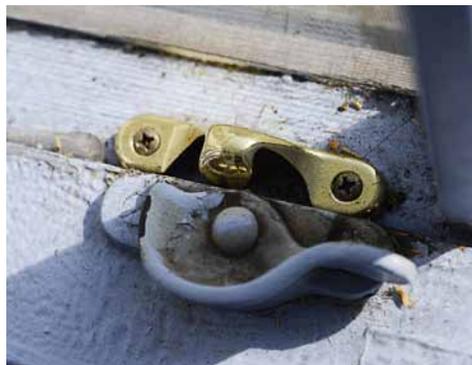
Photo 57: Typical modern replacement clam shell type sash lock. In many cases these are not functional due to mis-alignment of the sash, poor mounting, or other problems.

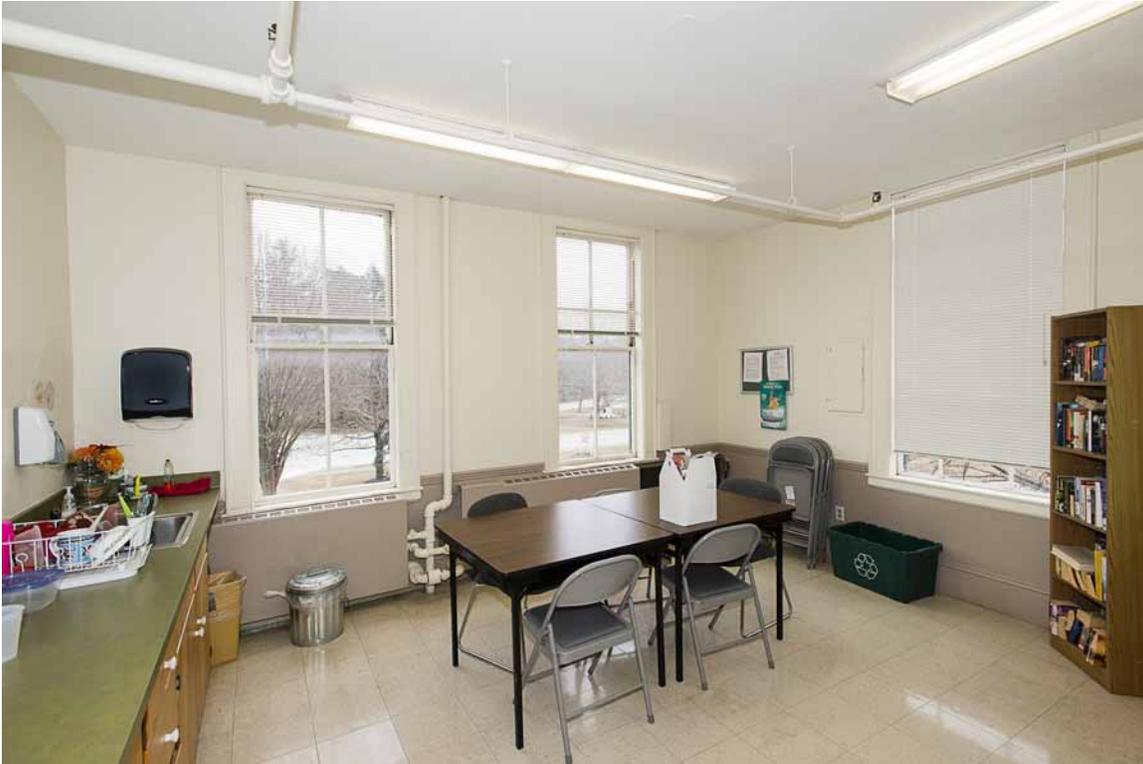
Photo 75: Southeast room on the second floor now used as a staff lunch room.

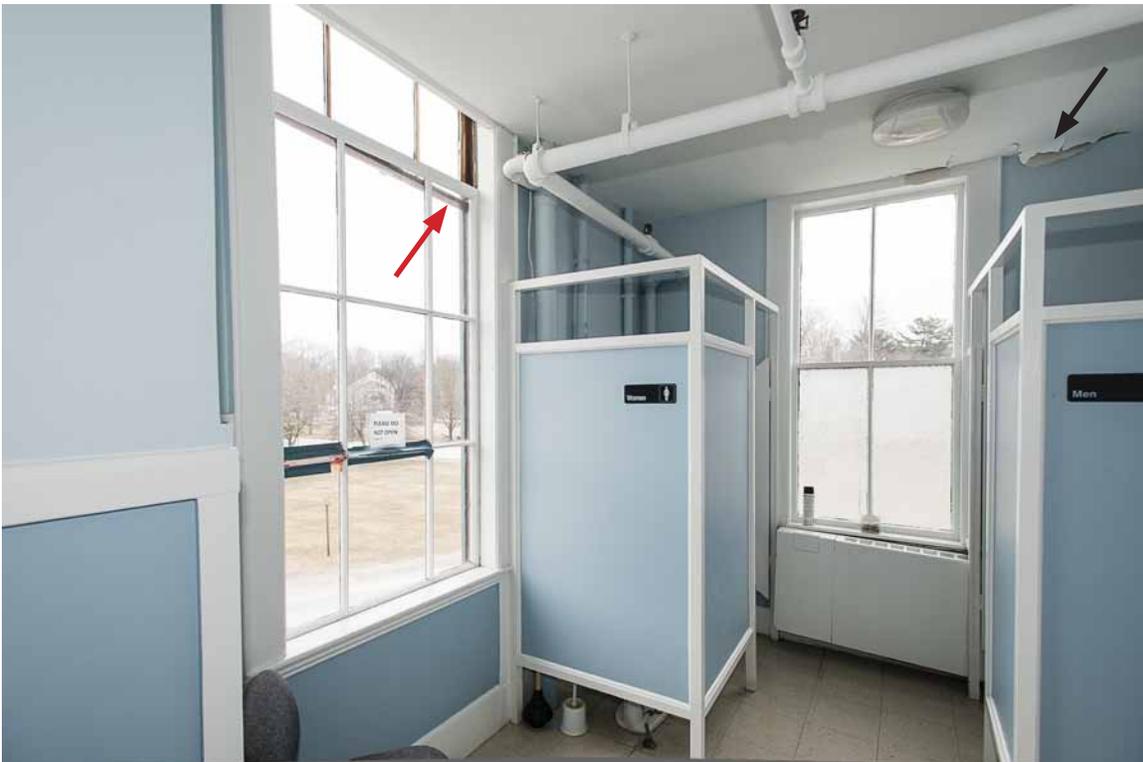
Photo 76: Northeast room on the second floor now used as a bathroom. The red arrow points to the upper sash meeting rail which has dropped down substantially from its original position (Window #27). The black arrow points to peeling paint from a past leak that is not believed to be current.

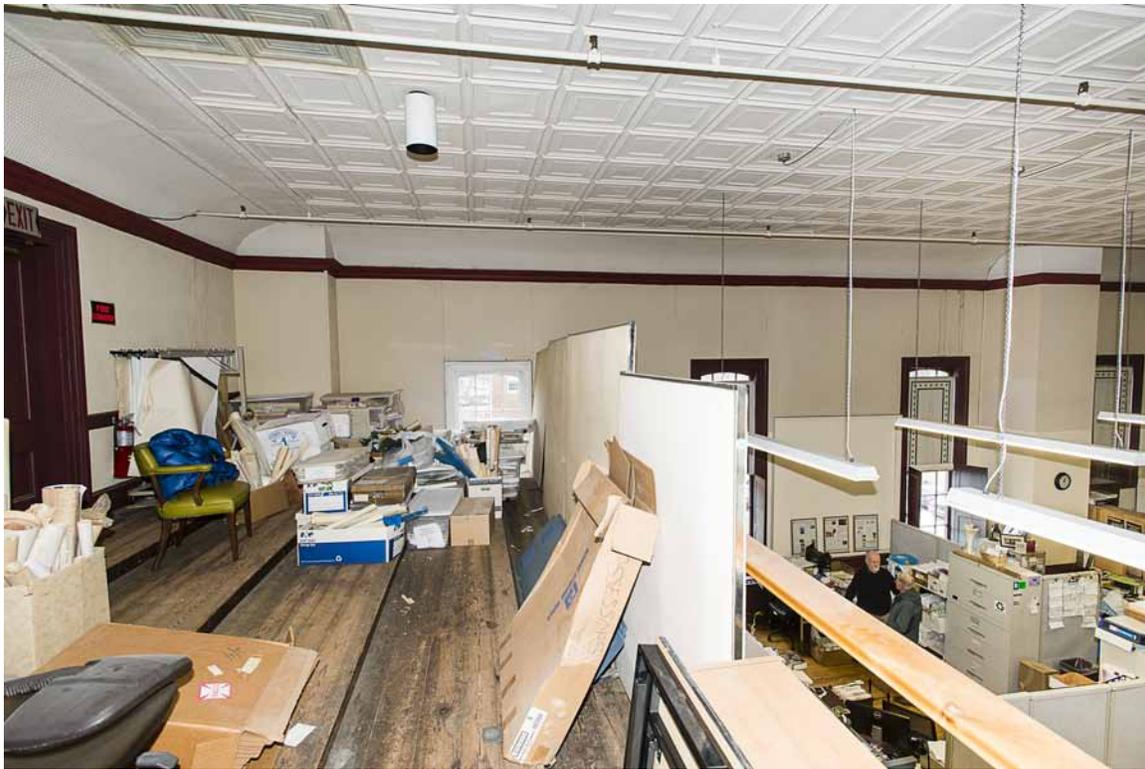
Photo 81: Meeting hall balcony looking towards the south wall.
